Client Name: John Smith
Inspection Address: 1234 SW 12 St #4, Miami, Florida 33156
Inspection Date: Thursday, October 05, 2017

PROPERTY-INFORMATION

Year Built: 2006/11-Years
Number of Stories: 2

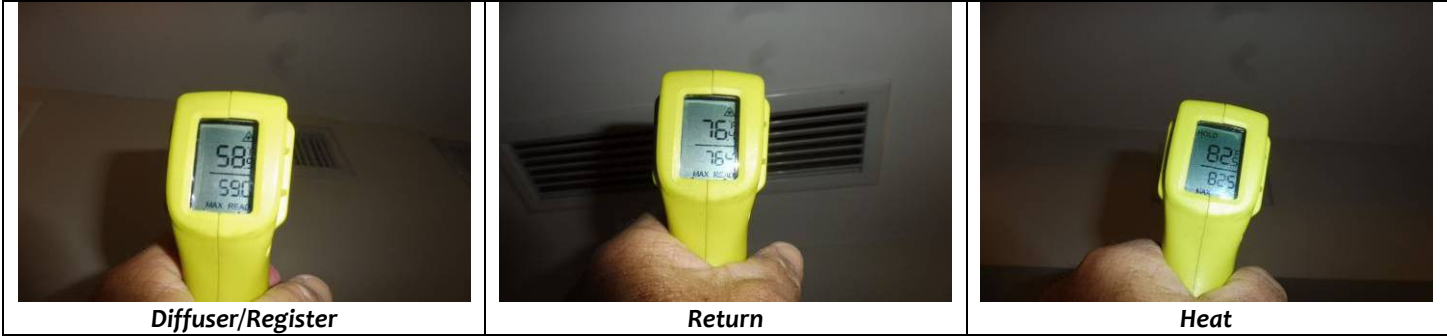
1. **Positive Attributes:** The air conditioning system operated with normal controls today and is functioning as intended (cooling cycle).
2. **Improve:** The coils are somewhat dirty and should be cleaned for the season. The system requires periodic servicing and maintenance.

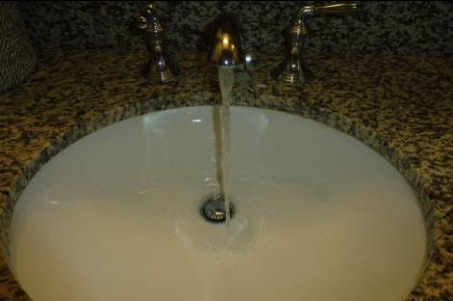
Notice: Water pressure running one fixture

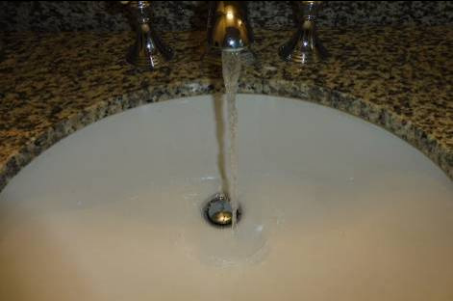
Notice: Water pressure running multiple fixtures simultaneously

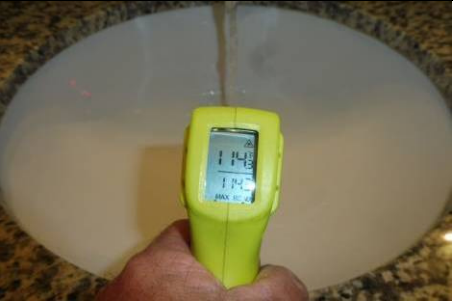
Positive Attribute: Hot water was obtained at **all** of the fixtures today.
