Client Name: Joe Smith  
Inspection Address: 2255 NE 23rd St, Fort Lauderdale, FL 33333  
Inspection Date: 10-11-2017

**PROPERTY-INFORMATION**

Year Built: 1967/50-Years  
Number of Stories: 2

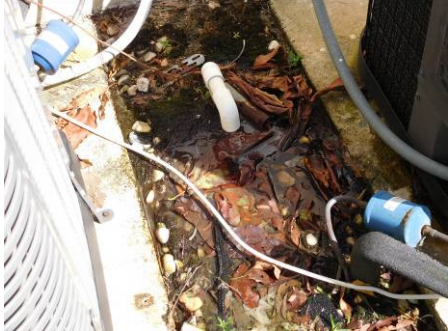
<p>Condensate lines should be directed away from the foundation</p>

- Improve:** The air conditioner condensate lines should be redirected away from the foundation walls.
- Improve:** Installing roof gutters will help keep water away from the foundation of the building.

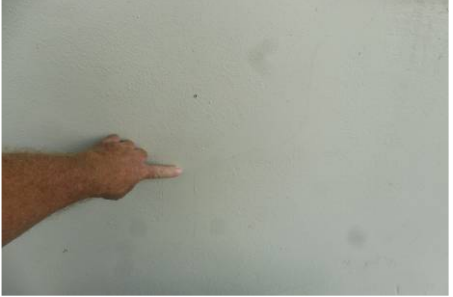
- Monitor, Investigate Further:** “Step” cracking was observed. This type of cracking is indicative of past or ongoing structural movement. *The size, pattern and location of these cracks **DO NOT** suggest a serious problem at present. In the absence of historical data or an accurate time-line, this/these crack(s) should be sealed, painted and carefully monitored for signs of ongoing movement and the need for further action.*  
**LOCATION(S): Right, Back and Left Elevations**
- Monitor:** In addition to the above observation, settlement/shrinkage cracks were observed at one or more locations. These cracks should be sealed, painted and monitored for signs of ongoing movement and the need for further action.

<p>Step Cracks</p>

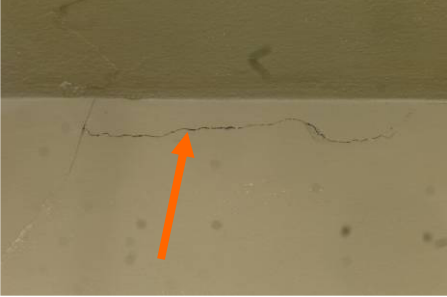
<p>Cracks</p>

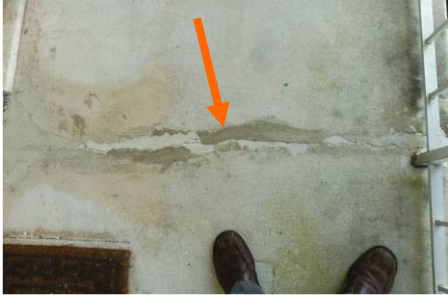
- Investigate Further, Possible Repair:** The walkway floor structure shows evidence of past or present downward movement (balconies). Multiple previously patched cracks were observed today. Several cracks appear to have re-opened, which may indicate ongoing movement. The visible evidence of movement does not appear to be considerable today; however, careful monitoring after sealing and painting is warranted to determine ongoing movement and the need for precautionary measures to be taken. **LOCATION(S): Multiple**

<p>Cracks in the walkways (D1)</p>

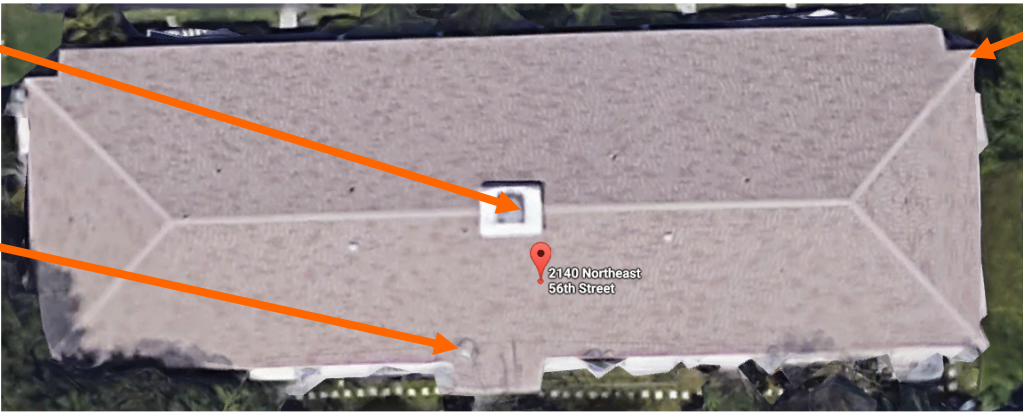
Tree trimming needed

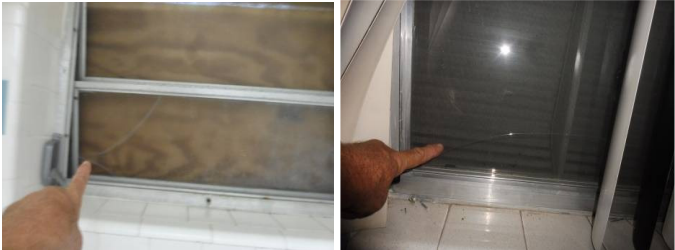
1. **Safety Repair:** The window is cracked and repair/replacement is needed. In some cases, replacing the entire window may be more cost effective than performing localized repairs. **LOCATION(S):** Apartment #12 (bathroom) and #8 (bedroom)

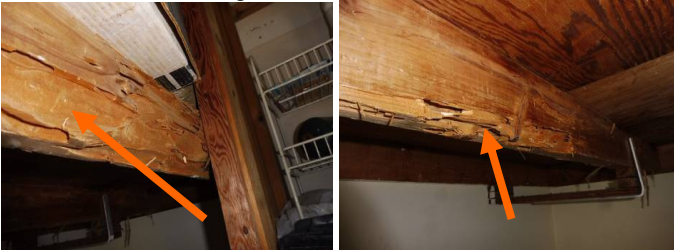
1. **Pest Treatment Recommended:** Pest activity/damage was observed in the visible wood members. The visible evidence does not appear to be considerable; however, hidden activity or damage should be anticipated. Beware of hidden damage. Pest treatment is recommended.

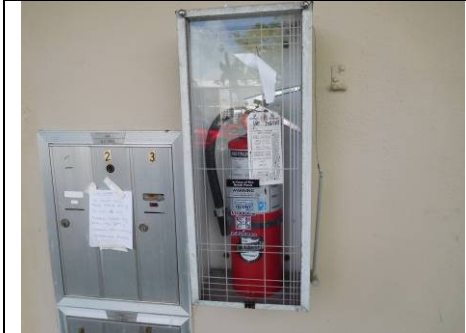
Extinguishers

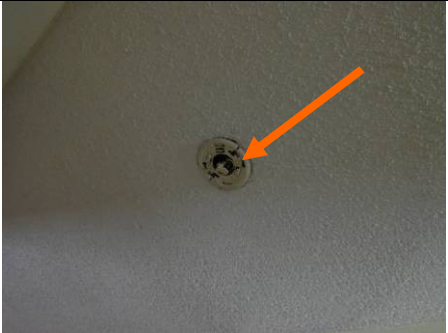
Missing Smoke Detectors #11

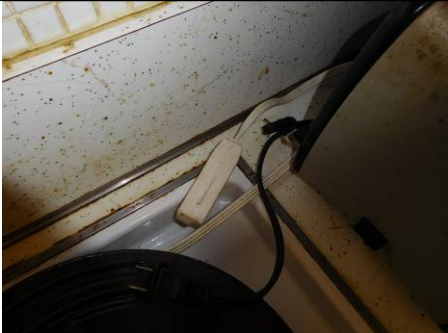
Extension Cord # 11

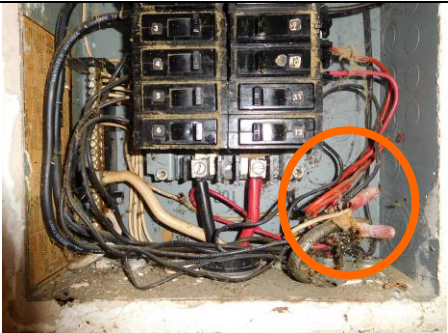
#2 Improper splices / Fabric Wiring

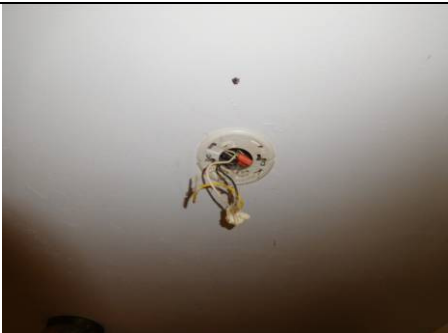
Missing Smoke Detectors #2

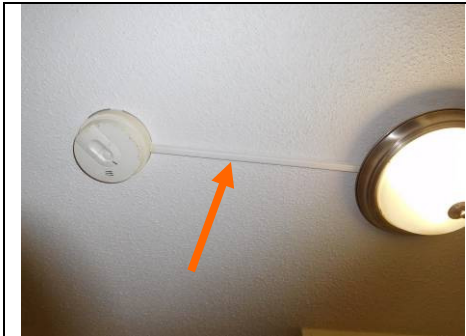
#4 Wiring in Raceway

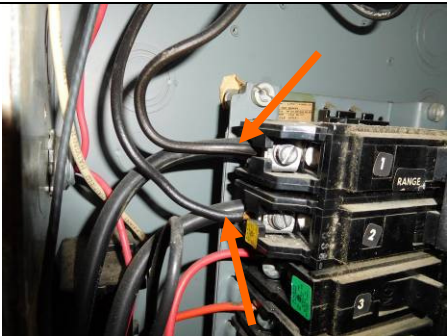
Oversized Breaker and Double Tapped #5

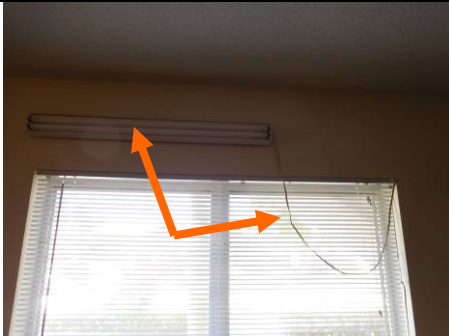
Improper light fixture and extension cord use #6

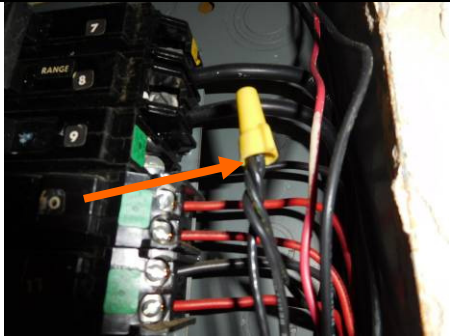
Improper Splices # 1 (may be a double tap)

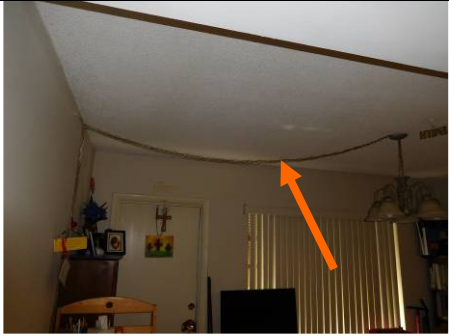
Extension Cords #1

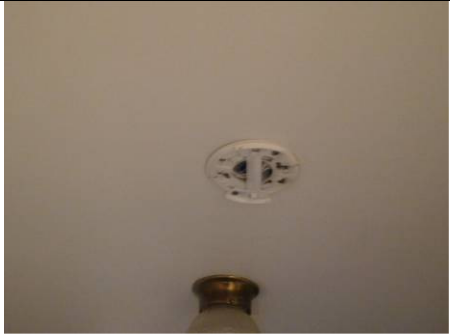
Missing detector #3

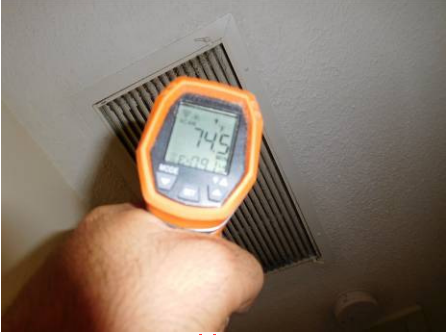
<p>#10 Return (❌ 8 degree temp difference)</p>	  <p>AC leak #10</p>

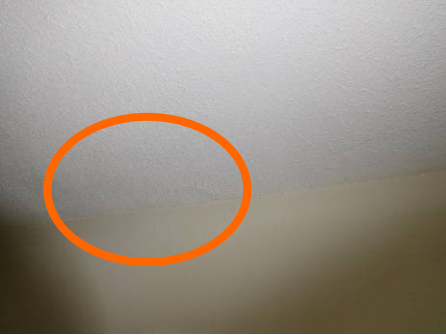
<p>AC leak #10</p>

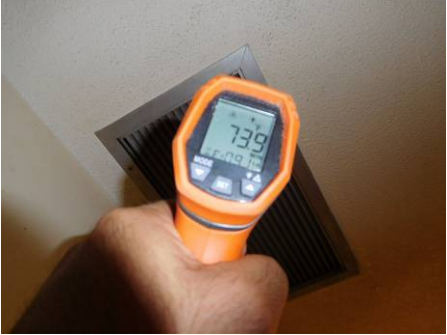
<p>#9 Return (❌ 8 degree temp difference)</p>

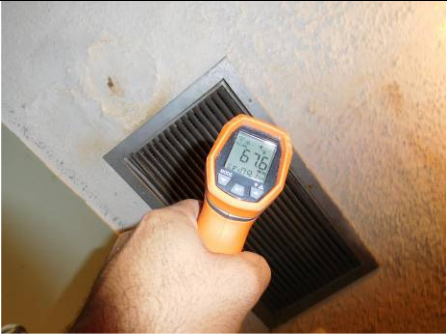
<p>#8 Return (❌ 9 degree temp difference)</p>

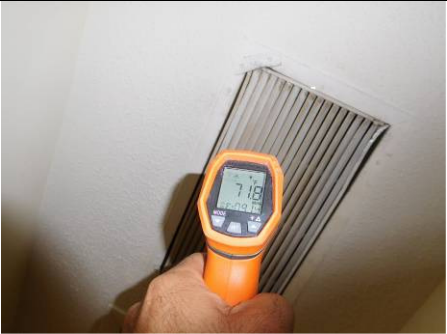
<p>#7 Return (❌ 10 degree temp difference)</p>

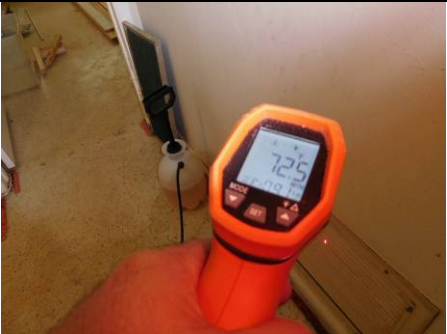
<p>#2 Return (❌ 6 degree temp difference)</p>

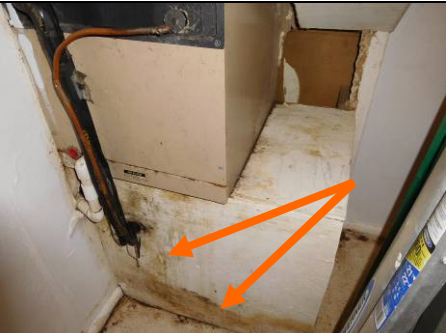
<p>Air handler leaking #2</p>

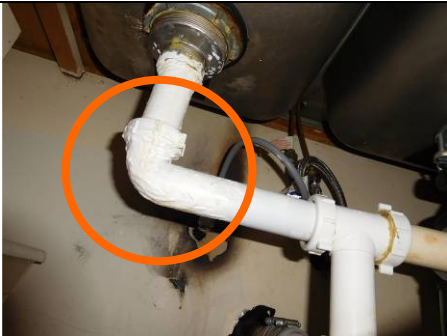
Trap Suspect Kitchen #9

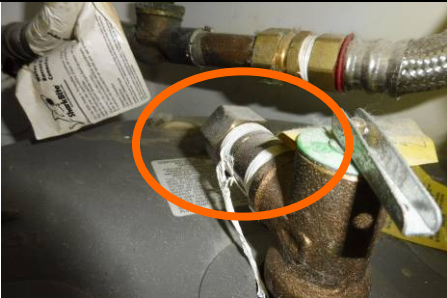
TPR at water heater missing

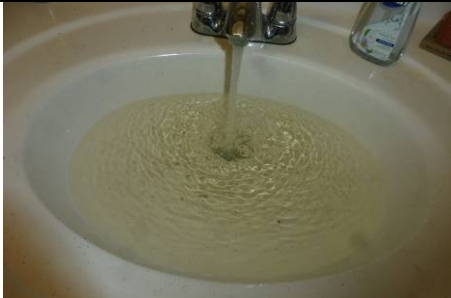
Slow draining plumbing fixtures

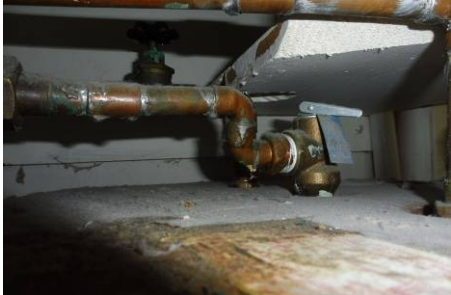
Water heater TPR pipe improperly reduced in diameter

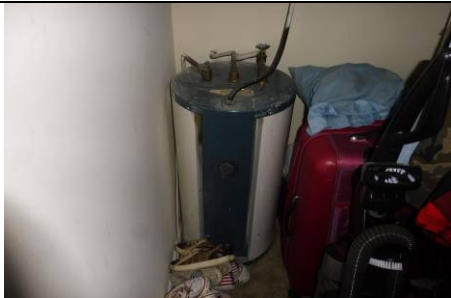
Very old water heaters

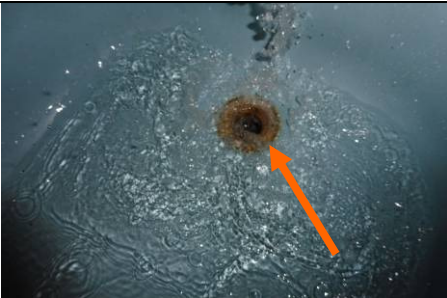
Corroded drain (tub #9)

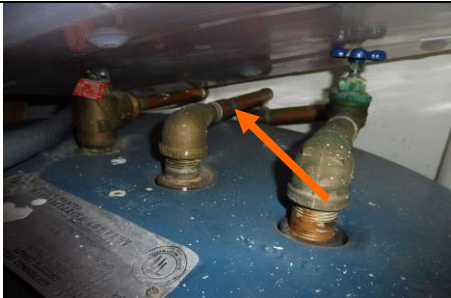
Water heater TPR pipe improperly reduced

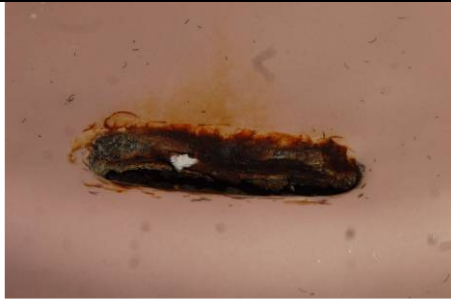
Corroded sink (#8)
