Atlantic Building Inspections

Property Inspection Report

1234 SW 56 Place, Miami, FL 33333

Date of Inspection: 1/30/2020 Time: 9:00 AM

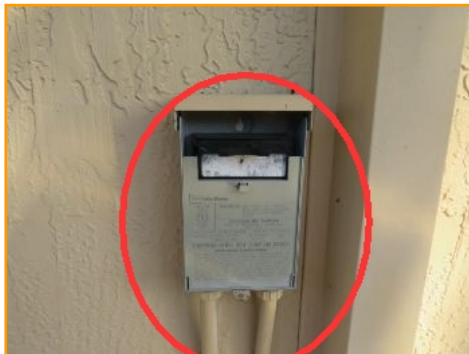
9.2. Replacement Item, Safety Concern: The dead front cover or inner cover is missing.

Missing Outer Cover

*Approximate Costs: (low) +/- \$75 to (high) +/- \$150 (per location), depending on conclusions, approach and further evaluation by licensed contractors.

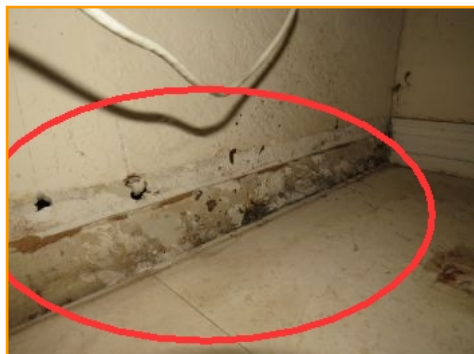
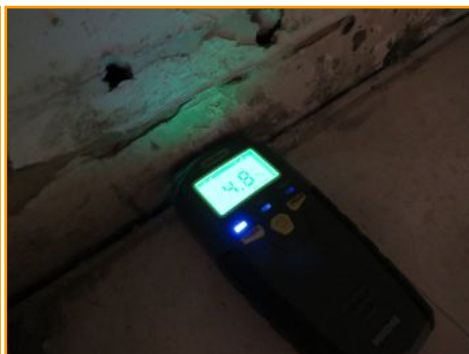
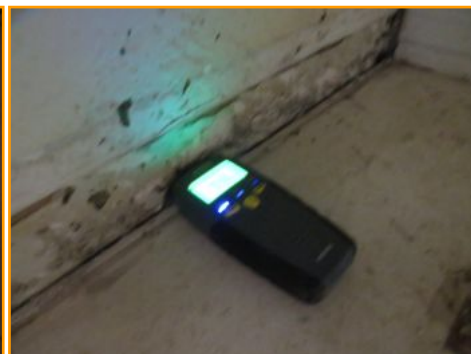
| Page 59 Item: 5 | Mold | <p>5.1. Investigate Further, Possible Repair: Evidence of, what appears to be, mold was observed (air handler closet) A/C #2. Mold detection is outside the scope of this inspection; however, it should be noted that not all molds are harmful and only laboratory testing can determine the type of mold, if any. The accessible area(s) tested dry with a moisture meter today. Mold testing is recommended. Ask the seller to disclose any historical data regarding mold. Consult a licensed mold assessor, before the end of your inspection period, for mold sampling. Atlantic Building Inspections is a State Licensed Mold Assessor (call the office if you wish to schedule a mold sampling). *the cost summary provided is for sampling/testing ONLY. Obtain remediation costs from a licensed mold remediator after obtaining laboratory analysis results.</p> <p>*Approximate Costs: (low) +/- \$350 to (high) +/- \$UNKNOWN (for MOLD testing ONLY), depending on conclusions, approach and further evaluation by licensed contractors.</p> |

Apparent Mold Like Substance

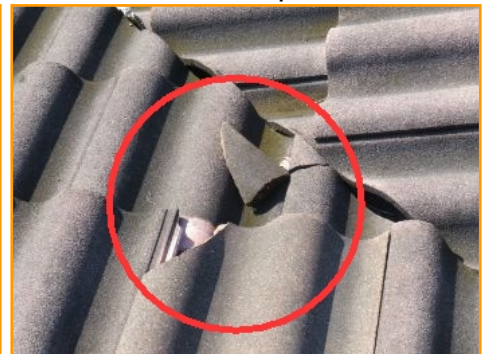
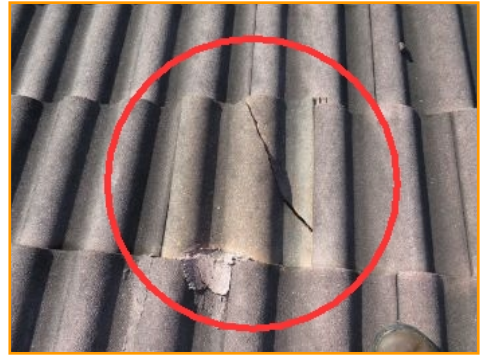
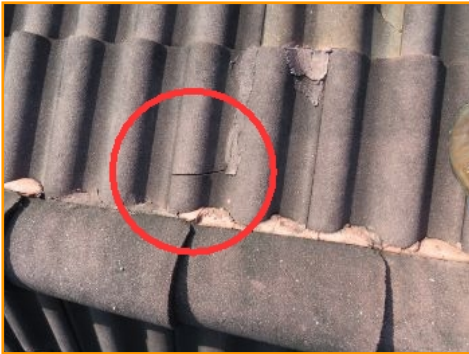
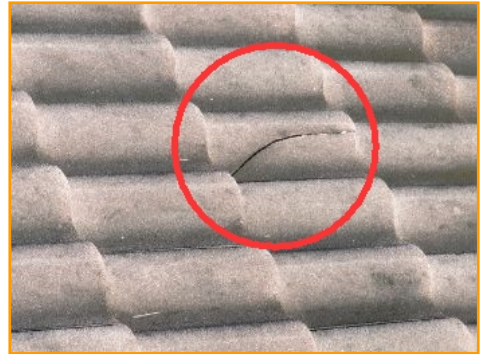
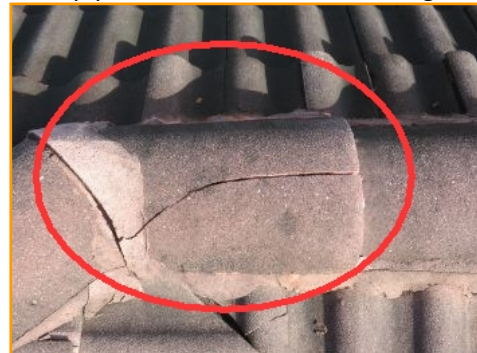
2.2. Repair: Missing or damaged roof tiles.

Damaged/Cracked Roof Tile(s)

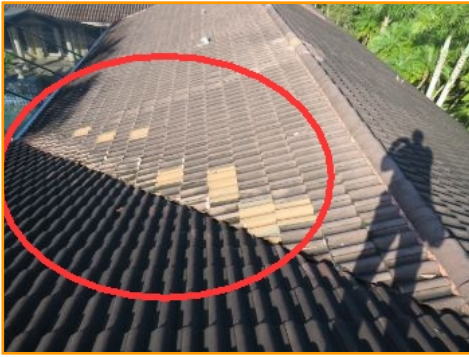
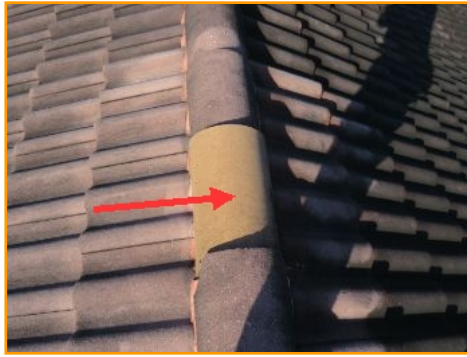
Previous Roof Repairs

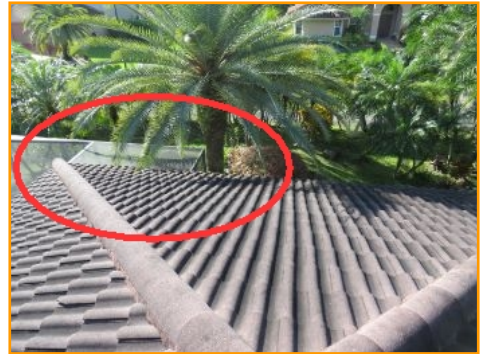
2.3. Improve: Tree trimming is recommended.

Trees Touching Roof

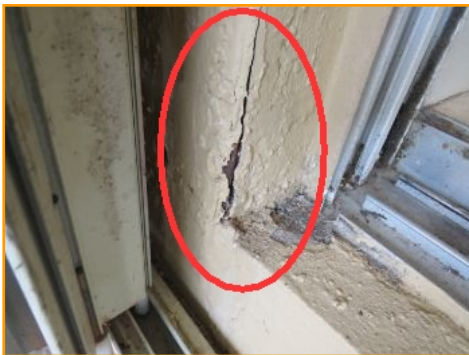
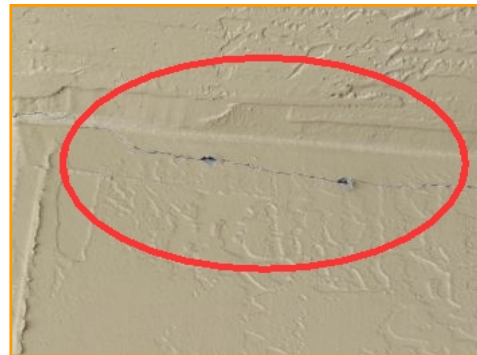
2.2. Repair: Stucco damage was observed at one or more locations. Identify all locations and repair as needed. Anticipate hidden damage (various locations throughout).

Stucco Damage/Cracks

*Approximate Costs: (low) +/- \$300 to (high) +/- \$500 (per location), depending on conclusions, approach and further evaluation by licensed contractors.

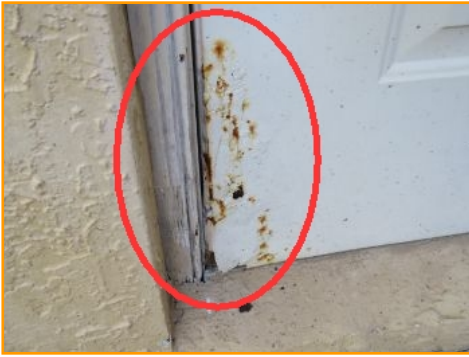
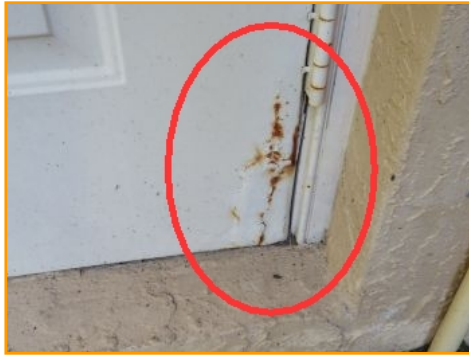
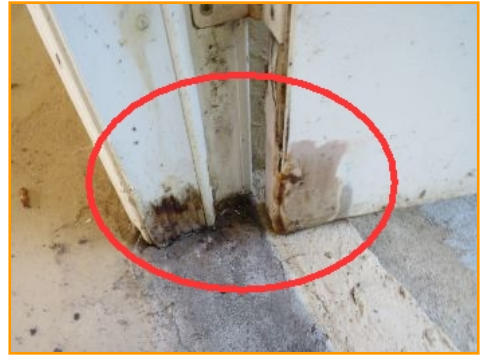
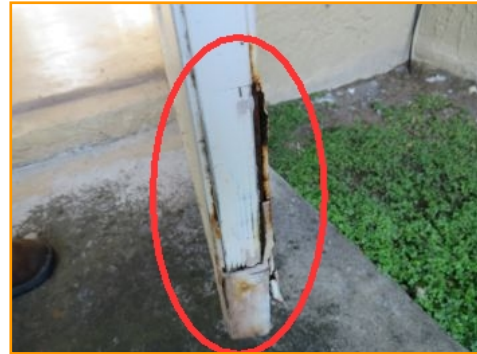
3.2. Repair/Replace: The door is water damaged and needs repair/replacement (garage)pedestrian back door.

Water Damaged

*Approximate Costs: (low) +/- \$500 to (high) +/- \$1500 (per door), depending on conclusions, type, style, materials, approach and further evaluation by licensed contractors.

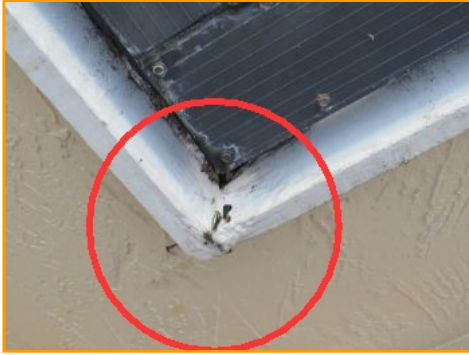
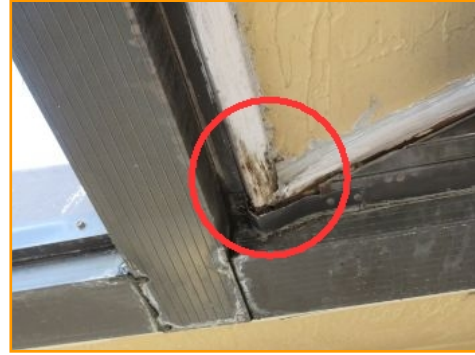
5.2. Repair: Water damage was observed (back exterior elevation) Locate all instances and repair/replace wood as needed. Anticipate hidden damage.

Moisture Damaged Fascia

*Approximate Costs: (low) +/- \$300 to (high) +/- \$400 (per location), depending on conclusions, approach and further evaluation by licensed contractors.

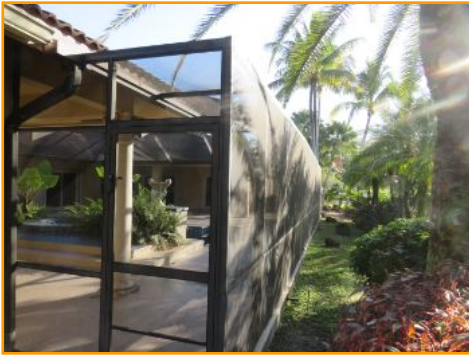
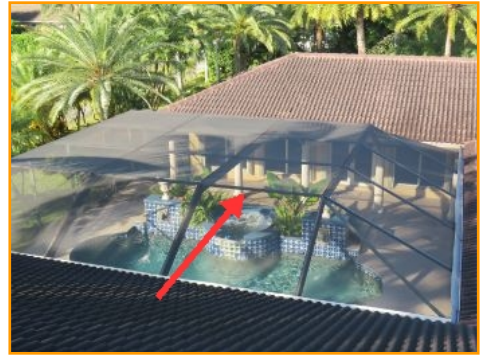
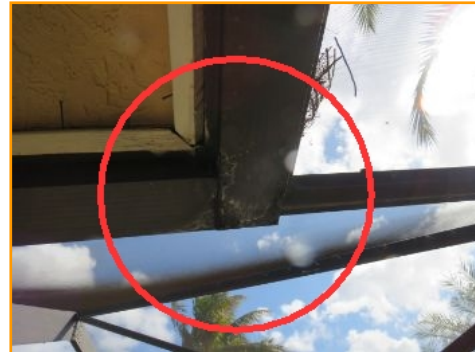
8.3. Repair/Replace: Beams damaged/corrosion was observed (various locations throughout).

Damage/Corroded

*Approximate Costs: (low) +/--\$150 to (high) +/--\$200 for further investigation ONLY, depending on conclusions, approach and further evaluation by licensed contractors. In this case, specific estimates need to be obtained from licensed contractors.

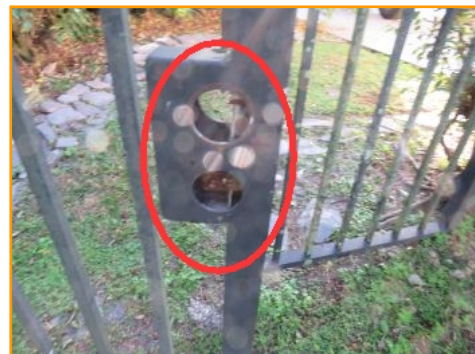
Damaged/Missing Hardware

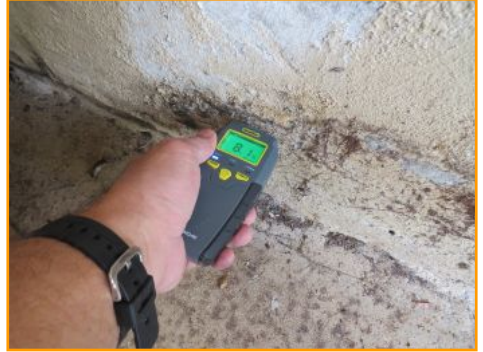
Dry Moisture Reading(s)

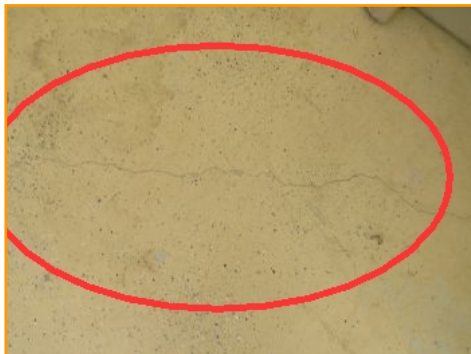
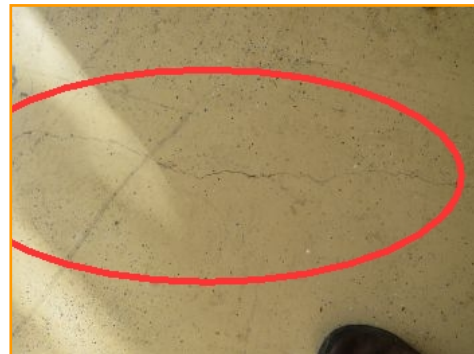
2.2. Monitor: Cracks were observed in the garage floor. The cracks are thin and do not appear to be a concern at the moment. Monitoring for signs of further movement should be adequate.

Settlement Cracks

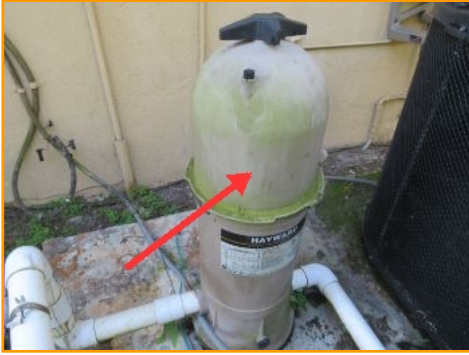
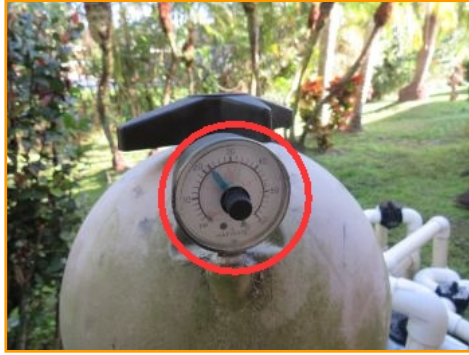
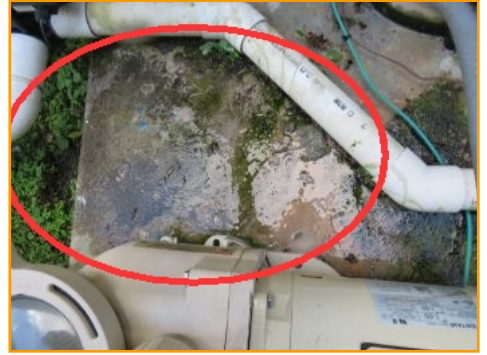
6.2. Repair: The filter was leaking at the time of inspection.

Leaking Filter

*Approximate Costs: (low) +/- \$225 to (high) +/- 375 (per location), depending on conclusions, approach and further evaluation by licensed contractors.

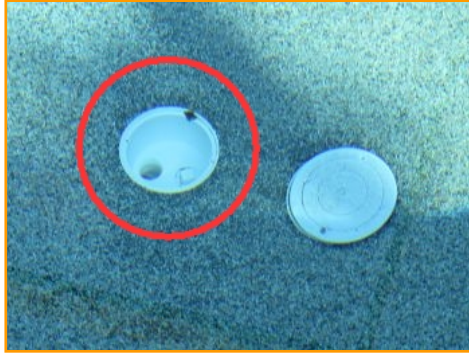
9.1. Safety Repair: One of the covers is missing. There have been hundreds of people, mostly children, injured or even killed by swimming pool drains.

Missing Cover

*Approximate Costs: (low) +/- \$300 to (high) +/- \$400, depending on conclusions, type, approach and further evaluation by licensed contractors.

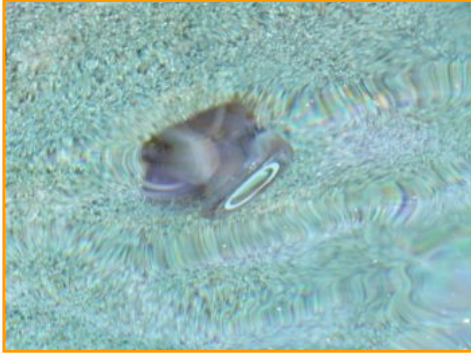
12.2. Safety Repair: The pool light housing is not installed flush to the pool surface. There is a space between the housing and the wall. Install the light properly as a child can become stuck in that space.

Lights Inoperative

*Approximate Costs: (low) +/--\$300 to (high) +/--\$400 (per location), depending on conclusions, approach and further evaluation by licensed contractors.

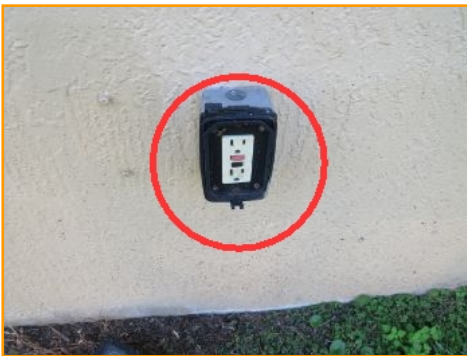
Missing/Damaged Weather Cover

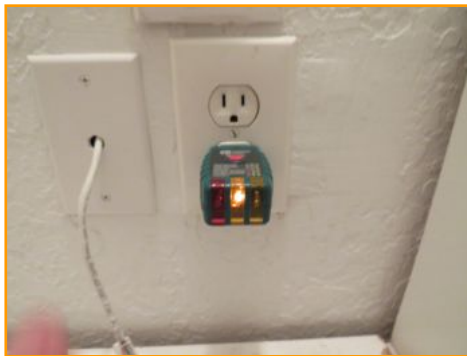
Ungrounded/Open Ground

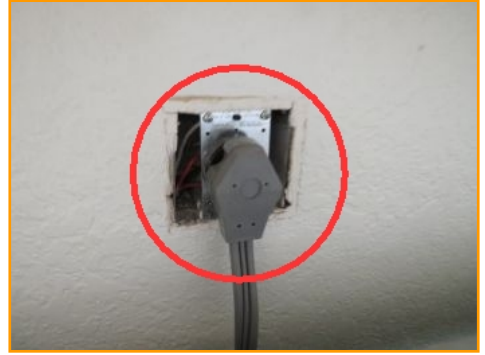
Missing Face Plate/Cover

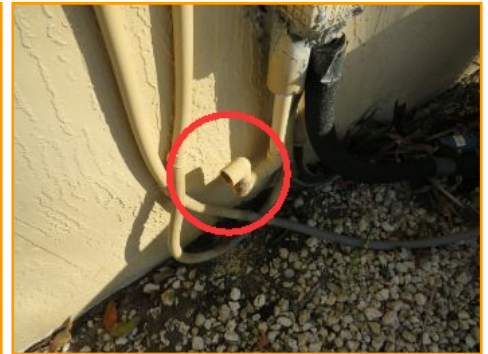
Condensate Near Foundation

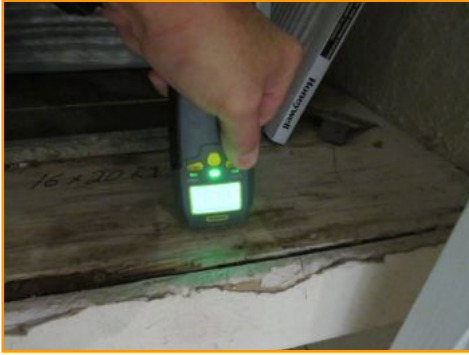
4.4. Monitor, Investigate Further: Water stains were observed in the walls, floors and or ceilings around or near the unit. The stains tested dry with a moisture meter today. *Beware of hidden damage and possible mold/mildew. These are typically found when water staining/damage is observed.

Slightly Wet Moisture Reading(s)

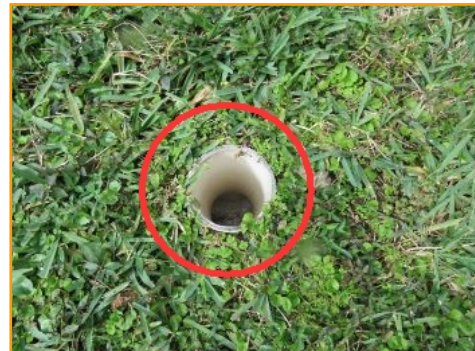
Clean Out Cover's Missing

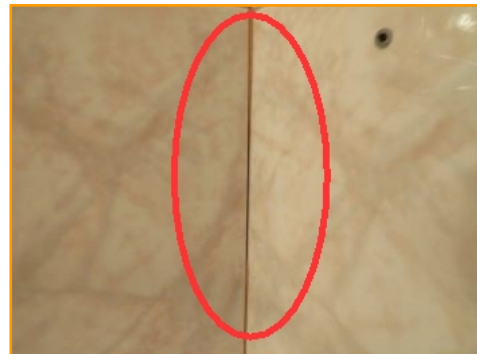
Deteriorated Grout

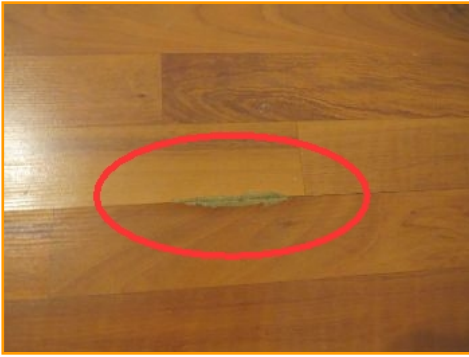
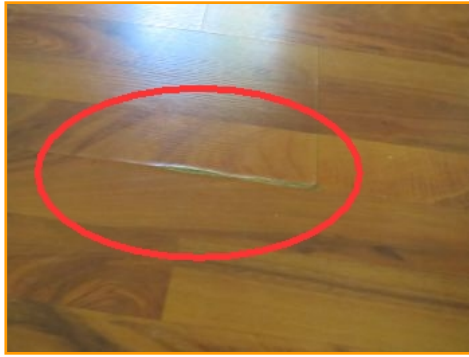
2.4. Investigate Further, Repair: Water stains were observed (guest bedroom)front. The stains tested WET with a moisture meter today.

Moisture Damaged

*Approximate Costs: (low) +/--\$150 to (high) +/--\$200 for further investigation ONLY, depending on conclusions, approach and further evaluation by licensed contractors. In this case, specific estimates need to be obtained from licensed contractors.

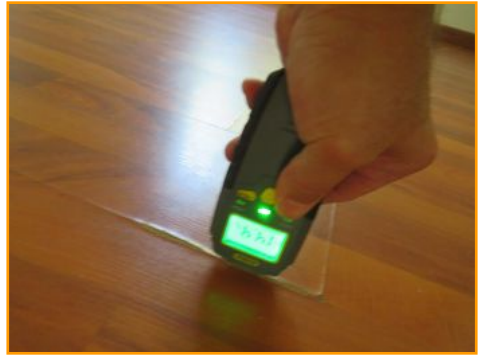
Slightly Wet Moisture Readings

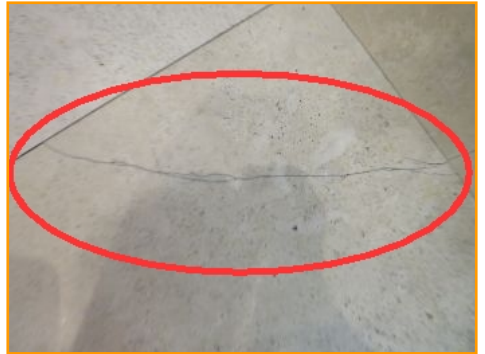
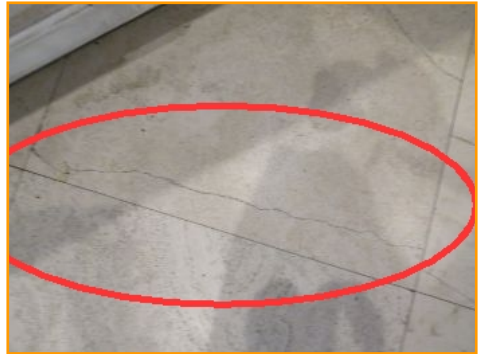
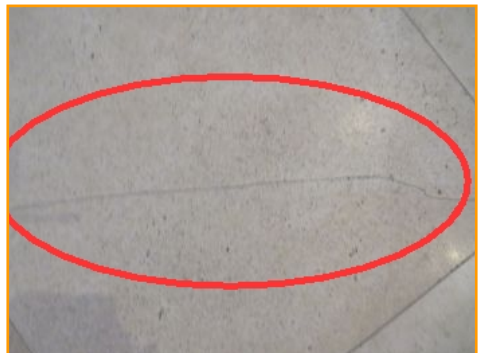
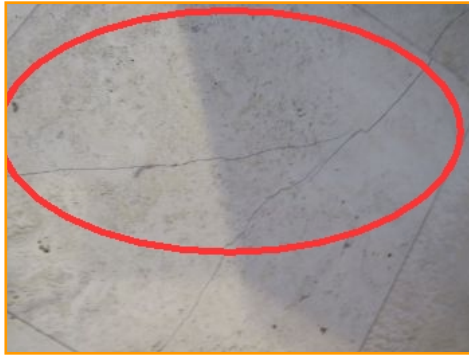
Cracks

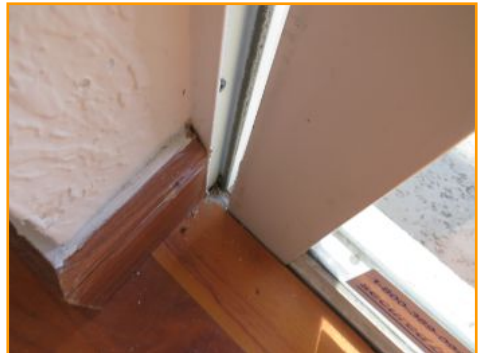
Door Binds/Hard to Open or Close

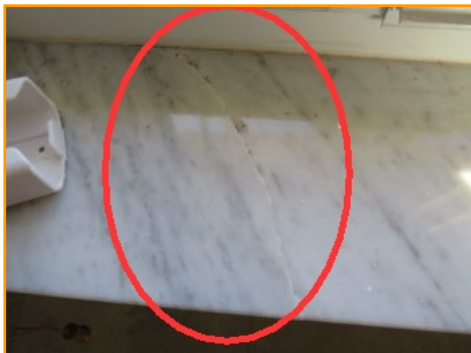
Damaged Window Sill

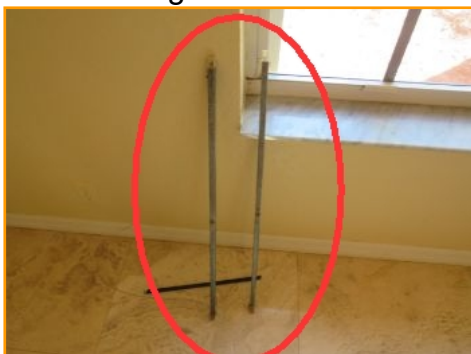
4.6. Safety Repair: The window springs/tension rods are damaged and the window closes abruptly (Dining Room). Care must be taken when operating the windows.

Damaged Springs/Tension Rods

*Approximate Costs: (low) +/- \$200 to (high) +/- \$300 (per location), depending on conclusions, approach and further evaluation by licensed contractors.

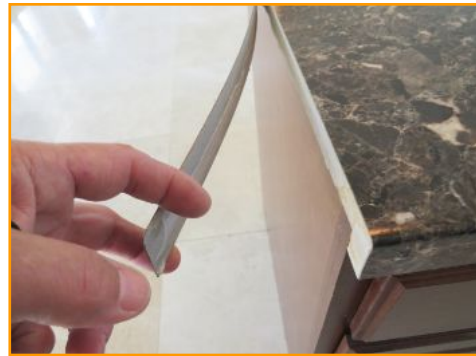
Loose/Damaged Laminate
