Atlantic Building Inspections

Property Inspection Report

SAMPLE REPORT

Date of Inspection: 1/18/2022 Time: 9:00 AM

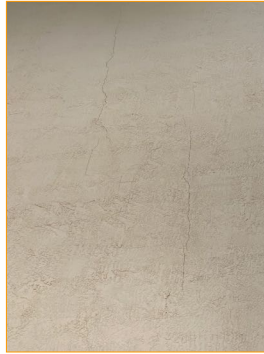
1.2. Monitor: Settlement/shrinkage cracks were observed at one or more locations. These cracks should be sealed, painted and monitored for signs of ongoing movement and the need for further action.

Cracks

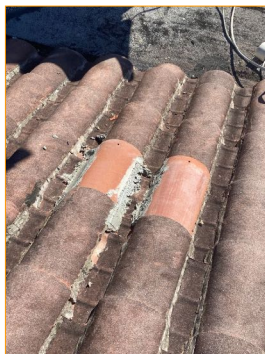
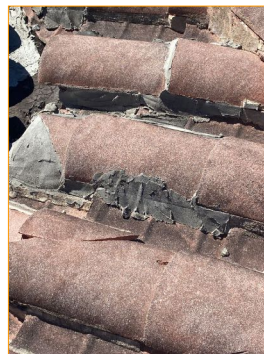
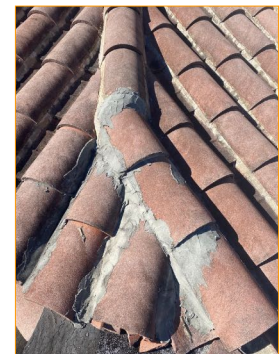
2.1. Significant Budget Item: An online BuildFax permit record search shows the roof was installed in 2003. This type of covering has an approximate estimated life span of 20-25 years +/- with frequent monitoring and maintenance. The visible roof coverings are old, deteriorating and in, generally, declining condition. In conclusion, the visible roof coverings are very near the end of their useful and serviceable life. Ideally, the roof should be replaced; however, repairs and preventative maintenance may prolong the life of the roof. In many cases replacing the roof coverings now will be more cost effective then performing repairs.

Previous Roof Repairs

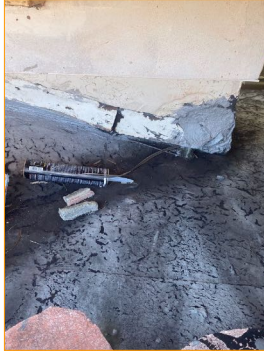
3.1. Monitor, Budget Item: All of the visible roof flashing is old, exhibiting signs of “wear” and should be replaced in combination with recommended near future re-roofing.

Previous Patching

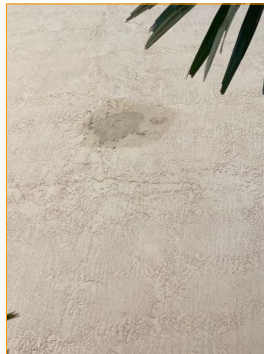
1.2. Repair: Minor stucco damage was observed (left exterior elevation). Identify all locations and repair as needed. Anticipate hidden damage.

Stucco Damage

*Approximate Costs: (low) +/--\$400 to (high) +/--\$600 (per location), depending on conclusions, approach and further evaluation by licensed contractors.

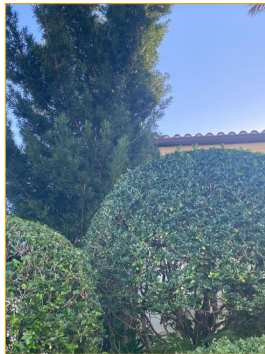
3.2. Improve: The proximity of several trees around the property could disrupt drainage pipes, cause mechanical damage to the exterior of the building or influence the foundation over time. It would be wise to consider removal and relocation of these trees.

Tree Proximity

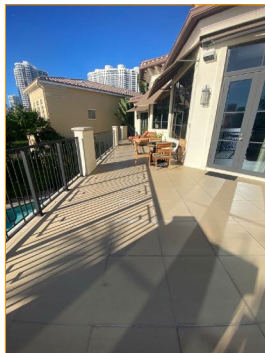
8.1. Investigate Further, Possible Repair: The balcony floor finishes are exhibiting signs of what appears to be calcium buildup. The source of this condition was not determined today. Ask the current owner to disclose any historical data regarding this condition and proceed cautiously.

Balcony

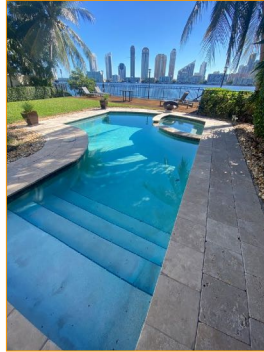
1.1. Monitor, Budget Item: The pool surface is exhibiting signs of discoloring and deterioration. Consult a licensed pool contractor for proper maintenance advice and information regarding re-surfacing.

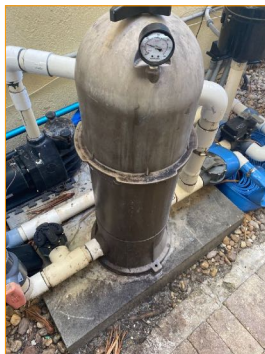
5.1. Repair: The filter gauge is damaged and or did not operate at the time of the inspection.

Filter

*Approximate Costs: (low) +/--\$150 to (high) +/--\$175, depending on conclusions, type, approach and further evaluation by licensed contractors.

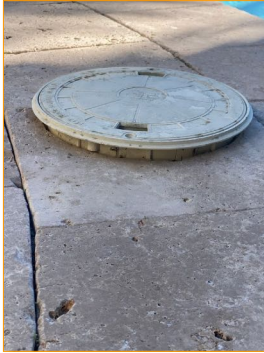
6.2. Safety Improvement: The pool deck presents a tripping hazard.

Tripping Hazards

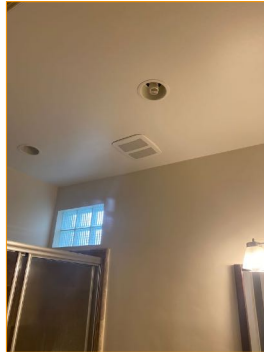
11.2. Investigate Further: Multiple light fixtures in the first floor guest bedroom are inoperative (guest bathroom ceiling). If the bulb(s) is/are not blown or missing, the circuit(s) should be repaired. Have the seller replace the bulbs and test all light fixtures during a final walkthrough for operability.

Inoperative

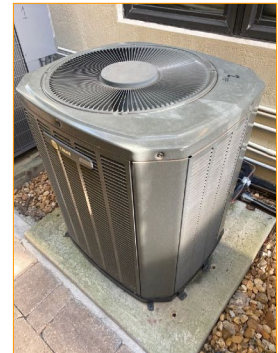
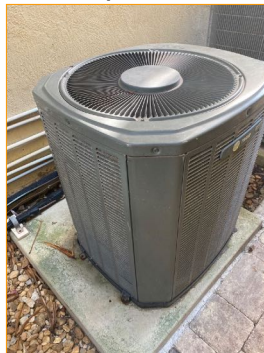
1.4. Significant Replacement Item: Units 2 and 3 are very old (obsolete). Based on the age, replacing the entire air conditioning systems is advisable in the near future. (interior and exterior units). Replacing the systems is more cost effective than performing any repairs.

Air Conditioner 2

Air Conditioner 3

*Approximate Costs: (low) +/- \$3,500 to (high) +/- \$5,500, depending on type, name brand, size, conclusions, approach and further evaluation by licensed air conditioning contractors.

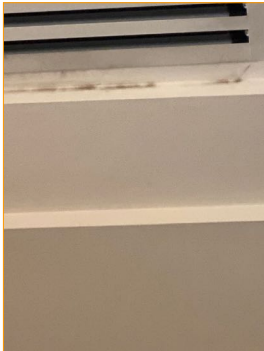
3.2. Air Quality Notice: Signs of, what appears to be, mold or mildew was observed at/in the diffuser cover (living area/room ceiling). Ask the seller about any known air quality issues before proceeding. Mold detection is outside the scope of this inspection. Testing for mold is recommended.

What Appears to be Mold

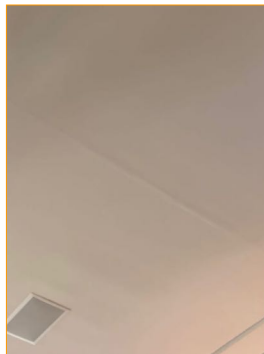
1.2. Investigate Further, Possible Repair: Bubbling paint was observed (living area/room ceiling). This condition may be due to water infiltration. The area tested was not accessible and could not be tested with a moisture meter today.

Bubbling paint/damage (not accessible)

*Approximate Costs: (low) +/- \$150 to (high) +/- \$200 for further investigation ONLY, depending on conclusions, approach and further evaluation by licensed contractors. In this case, specific estimates need to be obtained from licensed contractors.

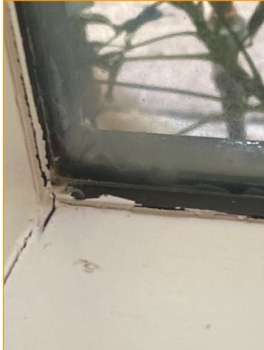
Interior Areas		
Page 38 Item: 4	Windows	<p>4.3. Safety Repair: The window pane delaminated/damaged. (various locations throughout).</p> <p>*Approximate Costs: (low) +/- \$1000 to (high) +/- \$2000 (per location), depending on conclusions, approach and further evaluation by licensed contractors.</p>
Powder Room		
Page 59 Item: 2	Sinks	<p>2.1. Repair: The trap is leaking . Anytime water is present and in contact with cellulose material, the opportunity for the existence of mold is possible. Beware of the possibility of "hidden" mold (it is not visible to the naked eye). Mold testing should be considered as part of due diligence).</p> <p>*Approximate Costs: (low) +/- \$200 to (high) +/- \$300 (per location), depending on conclusions, approach and further evaluation by licensed contractors.</p>

4.3. Safety Repair: The window pane delaminated/damaged. (various locations throughout).

Delamination

*Approximate Costs: (low) +/--\$1000 to (high) +/--\$2000 (per location), depending on conclusions, approach and further evaluation by licensed contractors.

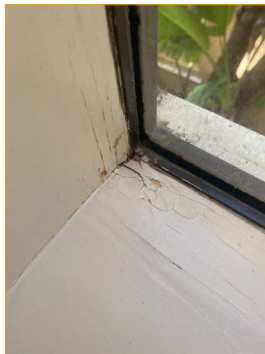
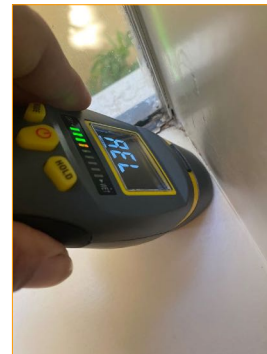
4.2. Monitor: Water stains, efflorescence and or moisture deterioration, near the windows, tested dry with a moisture meter today (STAIRS). Anytime water is present and in contact with cellulose material, the opportunity for the existence of mold is possible. Beware of the possibility of "hidden" mold (it is not visible to the naked eye). Mold testing should be considered as part of due diligence.

Efflorescence/damage (stairs)

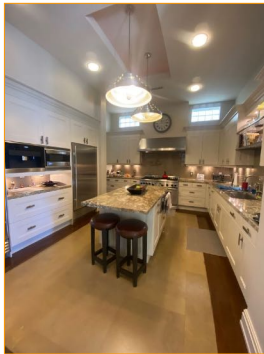
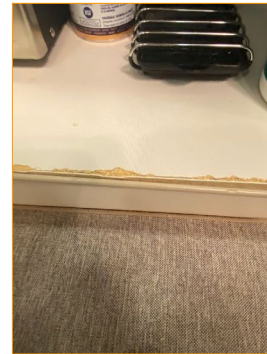
1.2. Repair/Replace: The cabinets are water or physically damaged and are in need of repair or possible replacement.

Damaged

*Approximate Costs: (low) +/- \$500 to (high) +/- \$2500++, depending on conclusions, approach, material used, and further evaluation by licensed contractors.

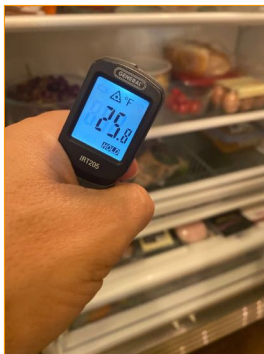
2.2. Budget Item: The refrigerator/freezer is very old. Normally refrigerators last about 9-13 years. Replacement is imminent. Note on life expectancy: Based on InterNACHI's Estimated Life Expectancy Chart for Florida Homes.

Refrigerator temperature

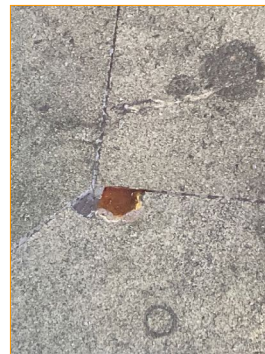
2.2. Repair/Replace: The tile shower stall requires repair. Damaged tile grout, and caulk should be repaired or replaced as necessary.

Damaged tile on floor

*Approximate Costs: (low) +/- \$425 to (high) +/- \$1500, depending on conclusions, extent of repair/replacement needed, approach and further evaluation by licensed contractors.

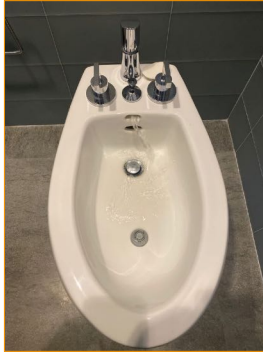
6.1. Repair: Poor water supply was obtained from the hot side today. The shut-off valves are not operated as part of this inspection. Have the seller demonstrate proper operation during a final walkthrough.

Poor hot water pressure

*Approximate Costs: (low) +/- \$200 to (high) +/- \$300 (per location), depending on conclusions, approach and further evaluation by licensed contractors.

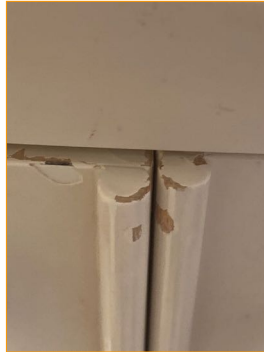
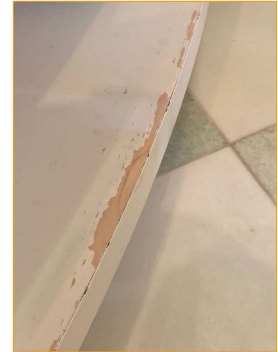
1.2. Repair/Replace: The bathroom vanity, cabinets, counter-tops or inner cabinet is water or physically damaged and in need of repair or replacement.

Cabinetry Condition

*Approximate Costs: (low) +/- \$850 to (high) +/- \$2500, depending on conclusions, type, material used, style, approach and further evaluation by licensed contractors.

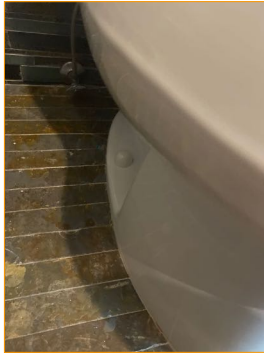
4.1. Improve: The toilet is loose. Consider changing the wax seal during tightening.

Loose

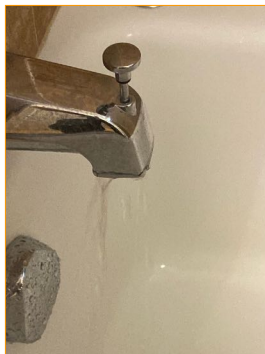
2.1. Repair/Replace: The diverter does not operate properly. Water continues to discharge, from the spout, when the showerhead is engaged.

Diverter

*Approximate Costs: (low) +/--\$225 to (high) +/--\$375 (per location), depending on conclusions, approach and further evaluation by licensed contractors.

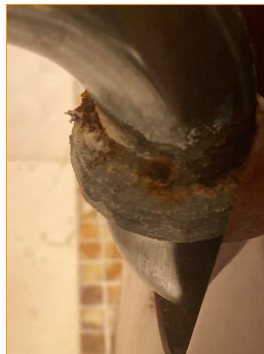
2.1. Repair: The trap is leaking . Anytime water is present and in contact with cellulose material, the opportunity for the existence of mold is possible. Beware of the possibility of "hidden" mold (it is not visible to the naked eye). Mold testing should be considered as part of due diligence).

Leaking

*Approximate Costs: (low) +/- \$200 to (high) +/- \$300 (per location), depending on conclusions, approach and further evaluation by licensed contractors.
