## Atlantic Building Inspections, Inc.

### HOME INSPECTION - INCLUDES WIND MITIGATION AND 4-POINT INSPECTION

100 Sample Avenue  
Sample City, FL 00000

INSPECTION DATE  
**September 17, 2026**

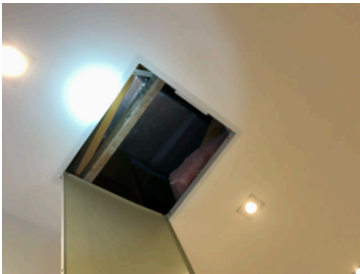
**VIEWED FROM HATCH**

Entering and maneuvering the attic space was not possible today. The attic was viewed from the access hatch. This restricted the inspection.

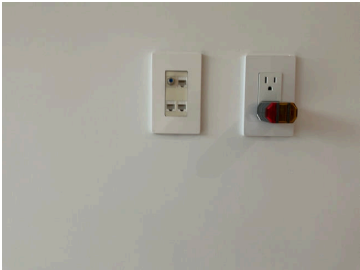
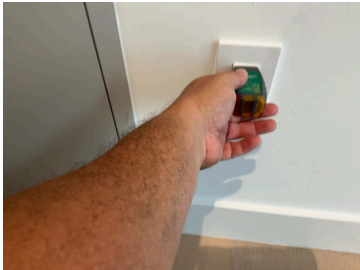
Master bedroom

5.14.1 · Visible Outlets

INOPERATIVE

Repair/Replace: The outlet is inoperative. <> \*Approximate Costs: (low) +/- \$175 to (high) +/- \$225 (per location), depending on conclusions, approach and further evaluation by licensed electricians.

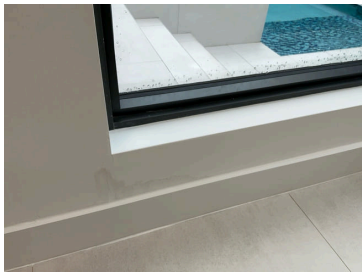
Florida Room

11.1.1 · Walls/Ceilings

STAINS/MOIST

Investigate Further, Possible Repair: Water stains were observed. <> The stains tested moist with a moisture meter today. Anytime water is present and in contact with cellulose material, the opportunity for the existence of mold is possible. Beware of the possibility of "hidden" mold (it is not visible to the naked eye). Mold testing should be considered as part of due diligence. \*Approximate Investigation Costs: +/- \$250 to +/- \$350 for further investigation ONLY, depending on conclusions and approach. In this case, specific estimates need to be obtained from licensed contractors before the end of your inspection period.

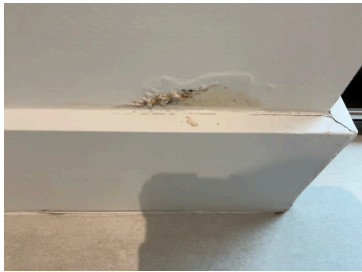
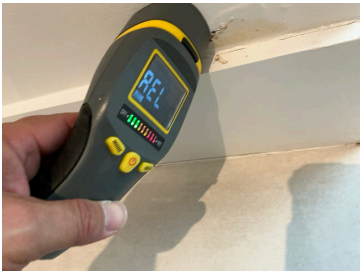
Second Floor Guest Bedroom

WET

Evidence of, what appears to be, mold was observed. Mold detection is outside the scope of this inspection; however, it should be noted that not all molds are harmful and only laboratory testing can determine the type of mold, if any. The accessible area(s) tested wet with a moisture meter today. Mold testing is recommended. Ask the seller to disclose any historical data regarding mold. Consult a licensed mold assessor, before the end of your inspection period, for mold sampling. Atlantic Building Inspections is a State Licensed Mold Assessor (call the office if you wish to schedule a mold sampling). \*the cost summary provided is for sampling/testing ONLY. Obtain remediation costs from a licensed mold remediator after obtaining laboratory analysis results. \*Approximate Costs: (low) +/- \$450 to (high) +/- \$UNKNOWN (for MOLD testing ONLY), depending on conclusions, approach and further evaluation by licensed contractors.

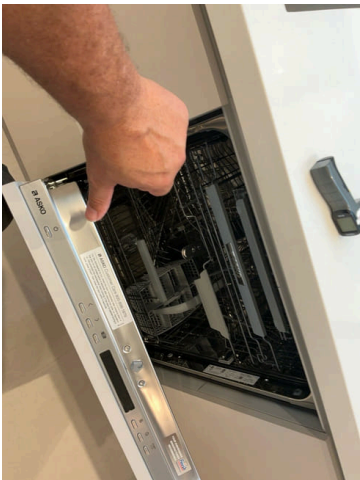
12.6.1 · Dishwasher

**INOPERATIVE**

Repair: The dishwasher did not operate when tested. Consult with the seller regarding this condition. \*Approximate Costs: (low) +/- \$400 to (high) +/- 950, depending on conclusions, approach and further evaluation by licensed contractors.

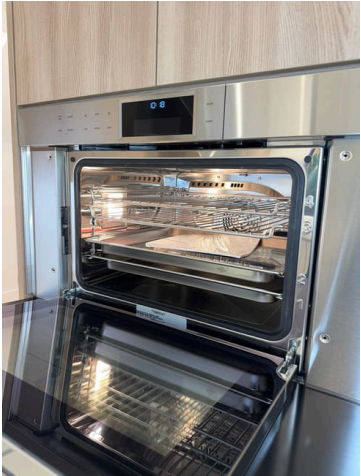
Steam Oven

Limitation: The steam oven is outside the scope of this inspection.

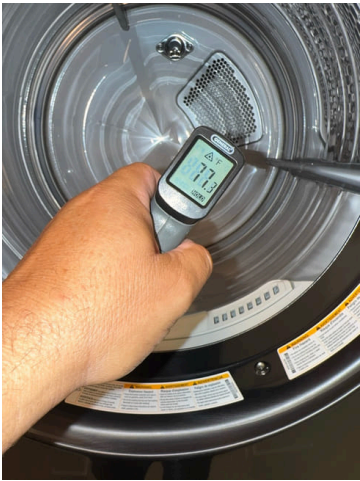
**NO HEAT**

Repair: The dryer did not produce heat with normal controls. This unit may be a newer model that requires what garments in order to produce heat. Ask seller to provide further information and proceed accordingly.
