## Atlantic Building Inspections, Inc.

### CONDOMINIUM INSPECTION - INCLUDES WIND MITIGATION AND 4-POINT INSPECTION

123 Sample Street  
Apt 000  
Sample City, FL 00000

INSPECTION DATE  
**September 3, 2026**

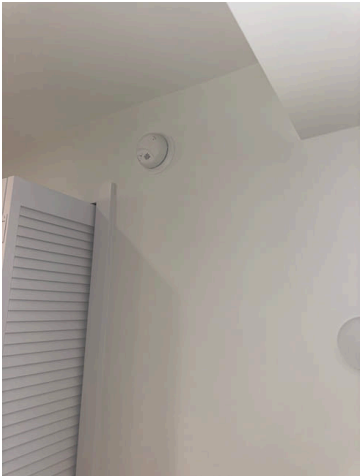
2.17.1 · Smoke Detectors

PRESENT NOT TESTED

Limitation, Notice: One or more smoke detectors were present today; however, smoke detectors are not tested as part of this visual inspection. It may recommended that additional units be added in all appropriate locations (this does not mean you need more; however, more units may be recommended). It would be wise to have the seller demonstrate proper function of all detectors. Installing smoke and carbon detectors (if there are gas appliances), in all appropriate locations, is strongly recommended.

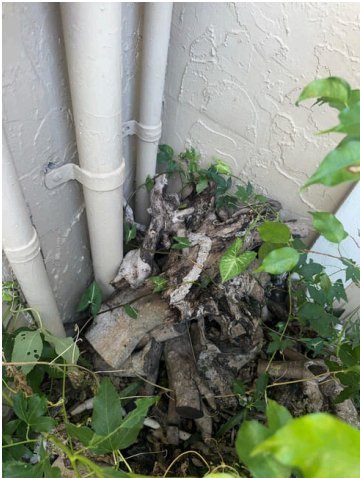
2.1.2 · Service Observations

FEEDER CONDUIT COVERED WITH WOOD

Investigate further : The main feeder conduit is covered with roots. This may be hiding conduit damage/corrosion. Further investigation by licensed electrician and removal of roots/wiod around is recommended.

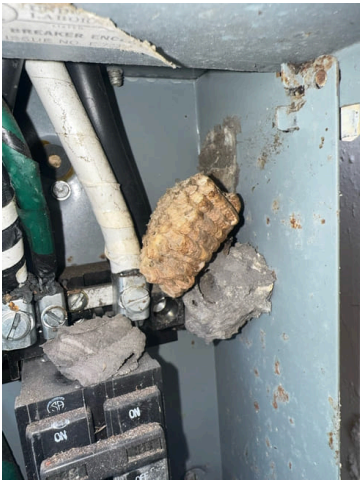
2.2.4 · Main Panel #1

Wasp Nest

Repair: The panel has hat appears to be a wasp nest inside. Removal is recommended.

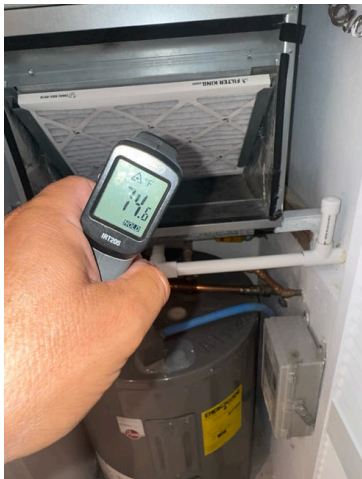
Return temperature/74

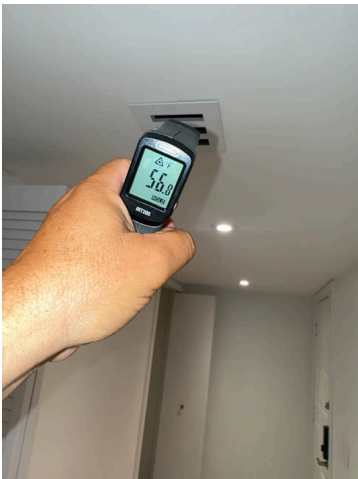
Supplie temperature/56

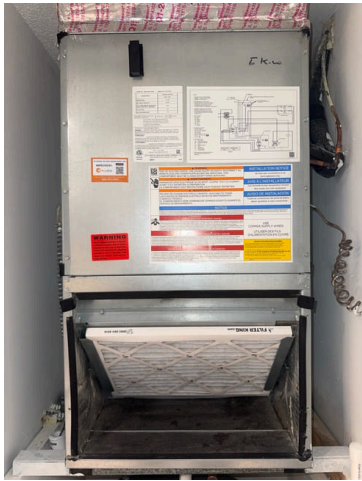
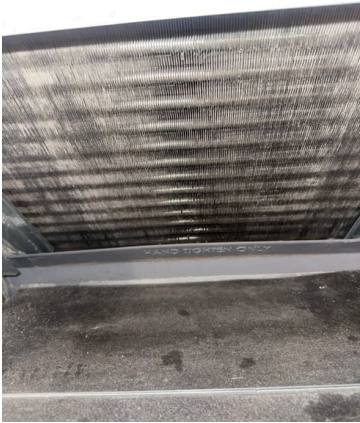
3.2.1 · Air Handler

**NEWER**

Positive Attributes: The unit is relatively newer. Regular maintenance will, of course, be necessary.

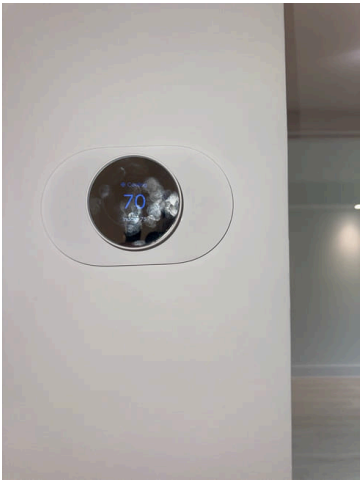
3.3.1 · Thermostat(s)

The thermostat(s) operated properly today.

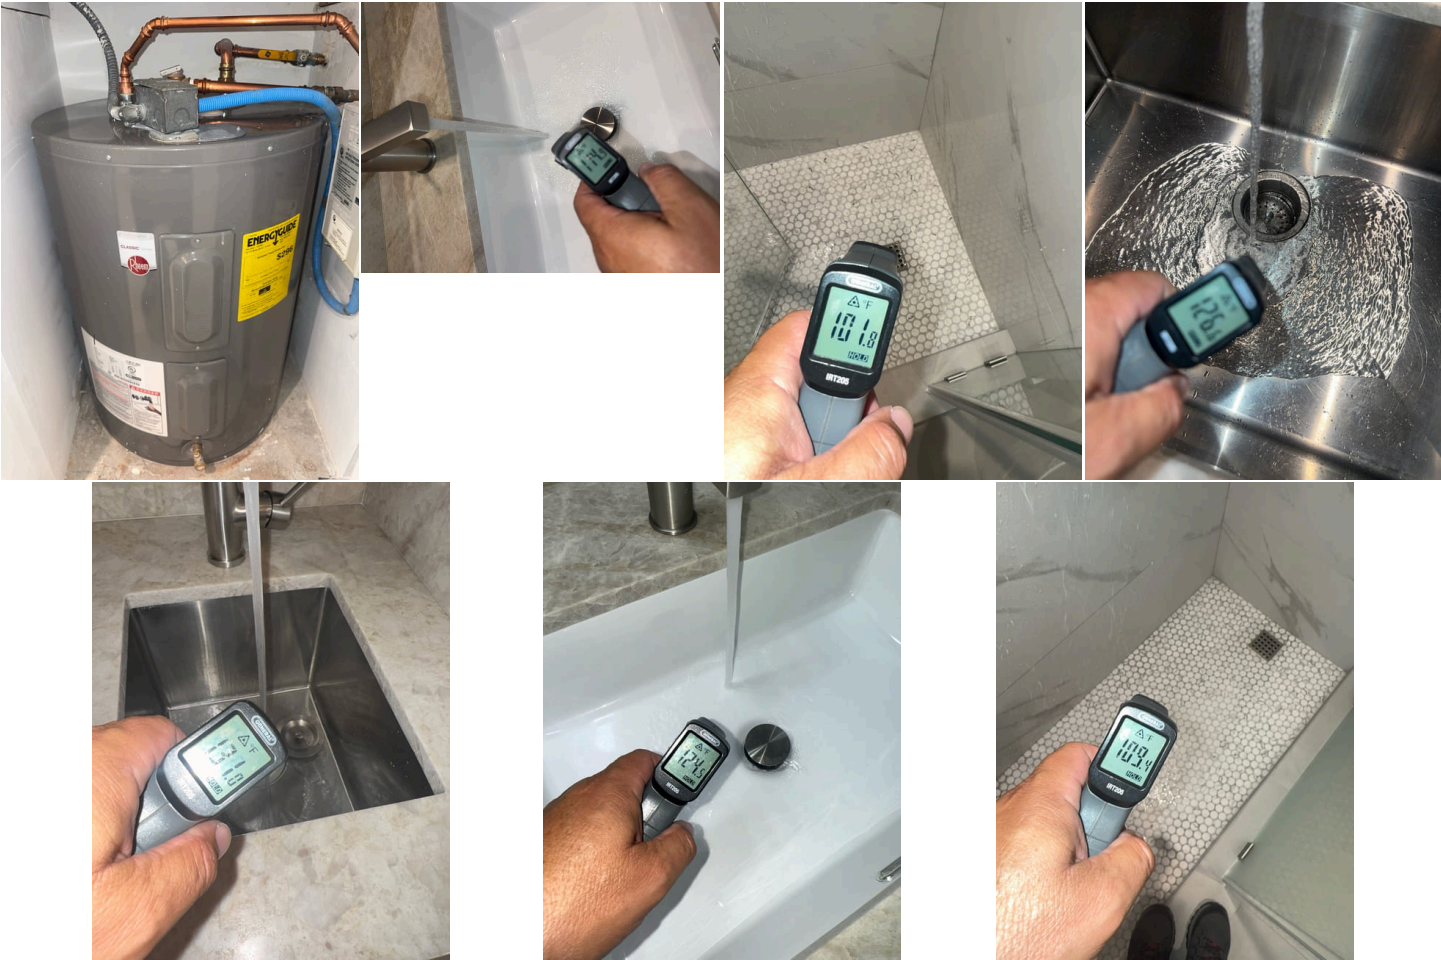
5.1.1 · Water Heater

NEW

The water heater is new or relatively newer and should have remaining useful and serviceable life. Ask the seller to provide any applicable warranties for the unit. Hot water was obtained at all of the fixtures throughout the property today.

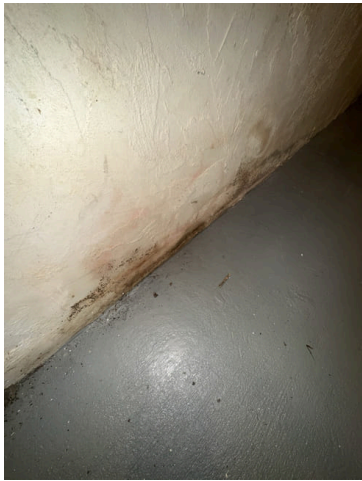
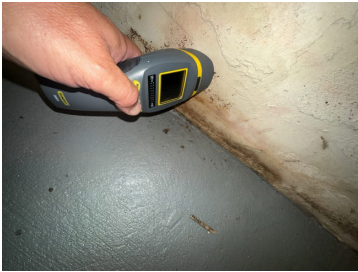
6.5.1 · Mold

DRY

Evidence of, what appears to be, mold was observed. Mold detection is outside the scope of this inspection; however, it should be noted that not all molds are harmful and only laboratory testing can determine the type of mold, if any. The accessible area(s) tested dry with a moisture meter today. Mold testing is recommended. Ask the seller to disclose any historical data regarding mold. Consult a licensed mold assessor, before the end of your inspection period, for mold sampling. Atlantic Building Inspections is a State Licensed Mold Assessor (call the office if you wish to schedule a mold sampling). \*the cost summary provided is for sampling/testing ONLY. Obtain remediation costs from a licensed mold remediator after obtaining laboratory analysis results. \*Approximate Costs: (low) +/- \$450 to (high) +/- \$UNKNOWN (for MOLD testing ONLY), depending on conclusions, approach and further evaluation by licensed contractors.
