Client Name: John Smith
Inspection Address: 1234 SW 12 St #4, Miami, Florida 33156
Inspection Date: Thursday, October 05, 2017

PROPERTY-INFORMATION

Year Built: 2006/11-Years
Number of Stories: 2

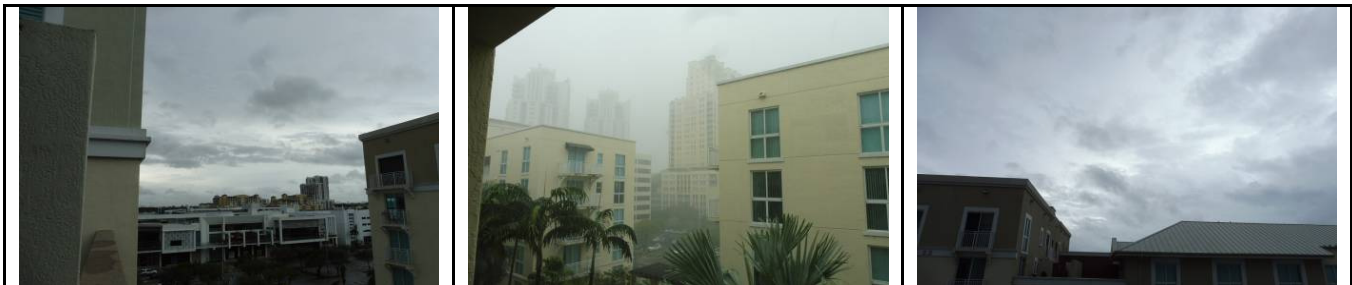
WEATHER PHOTOS

Heavy rainy weather conditions prevailed at the time of the inspection.
Wet weather was reported in the area in the days leading to the inspection.
80-90 degrees and raining heavy at the time of the inspection.

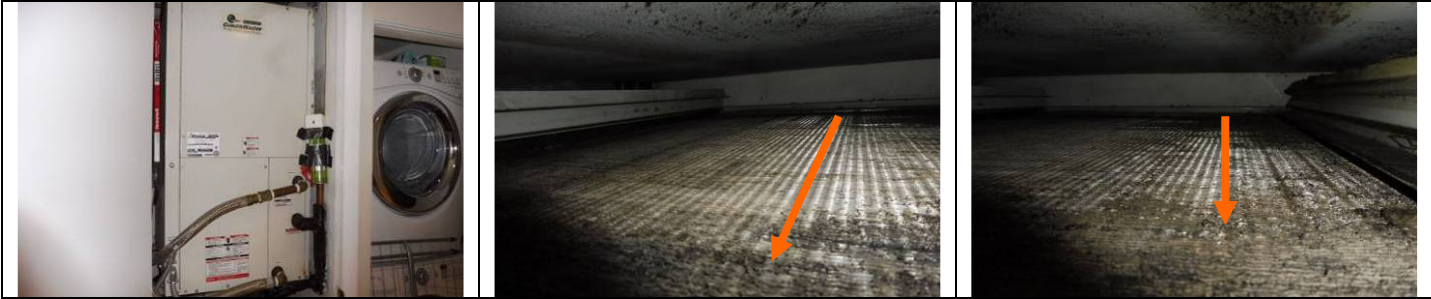
PHOTOS

1. **Positive Attributes:** The visible ductwork, in the accessible areas of the property appear to be in, generally, satisfactory/good condition.
