Client Name: Joe Smith  
Inspection Address: 2255 NE 23rd St, Fort Lauderdale, FL 33333  
Inspection Date: 10-11-2017

**PROPERTY-INFORMATION**

Year Built: 1967/50-Years  
Number of Stories: 2

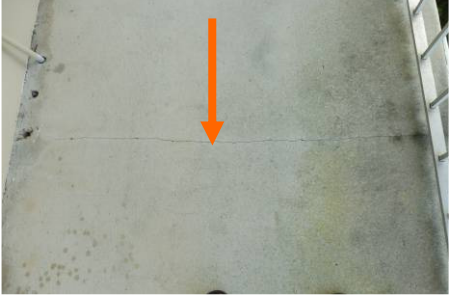
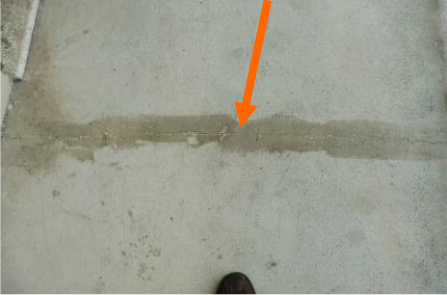
<p>D1</p>

<p>Cracks in the walkways (D1)</p>

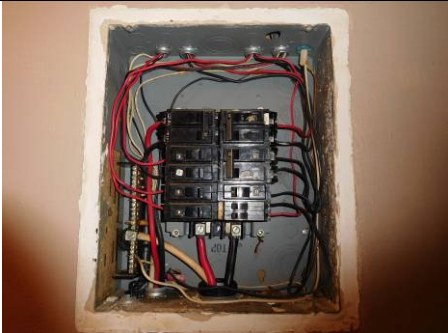
Raceway #8

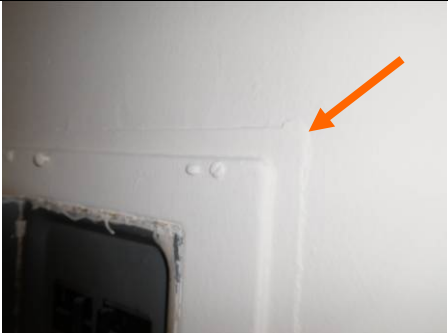
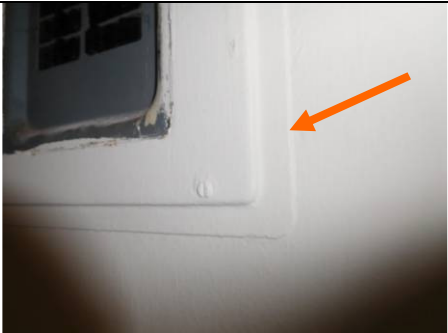
#7 Sub-Panel Cover Sealed-Not Removed

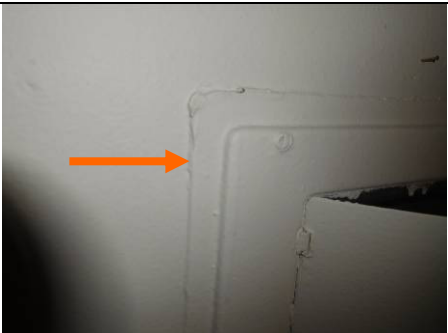
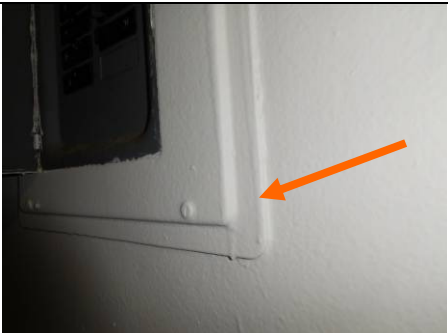
#4 Sub-Panel Cover Sealed-Not Removed

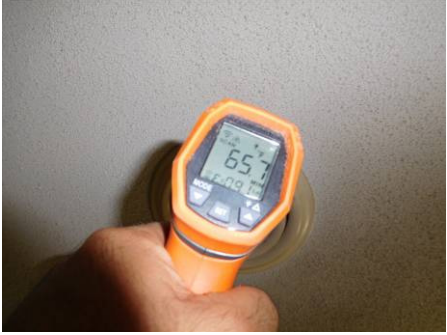
<p>#9 Return (❌ 8 degree temp difference)</p>

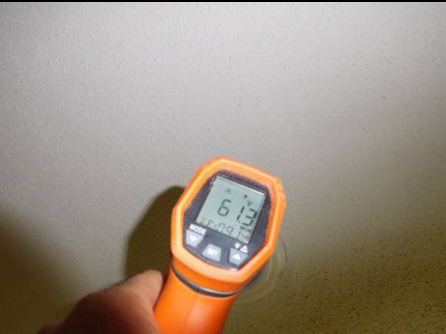
<p>#7 Diffuser</p>

<p>#7 Return (❌ 10 degree temp difference)</p>

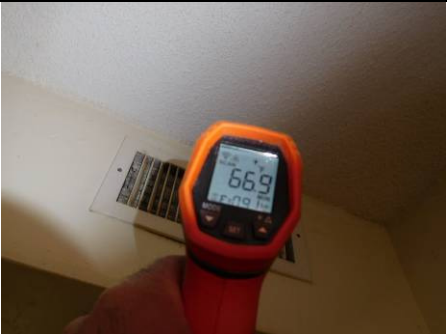
<p>#2 Diffuser</p>

<p>#2 Return (❌ 6 degree temp difference)</p>

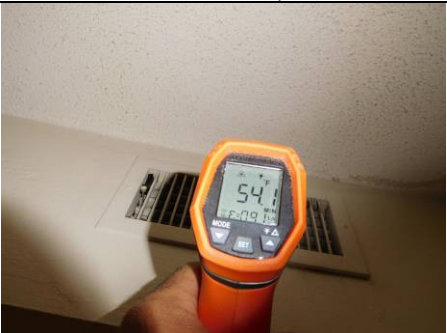
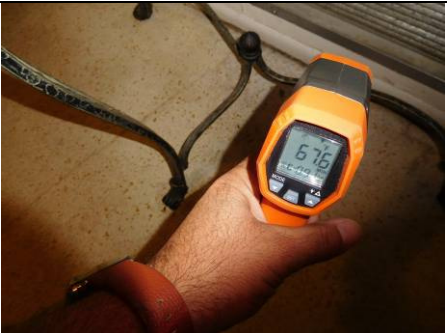
<p>#5 Diffuser</p>

<p>#5 Return (❌ 13 degree temp difference)</p>

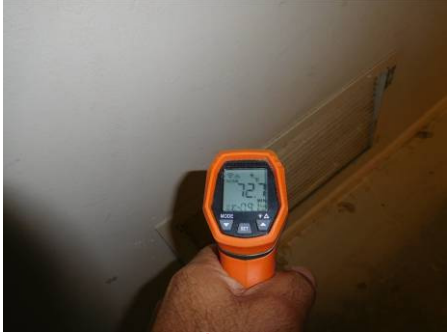
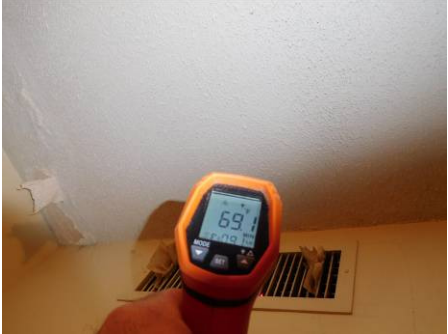
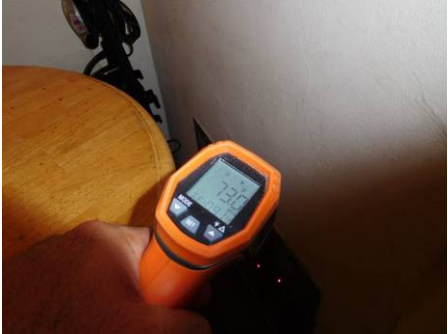
#1 Return (✓18 degree temp difference)	#3 Diffuser	#3 (✗ 4 degree temp difference)

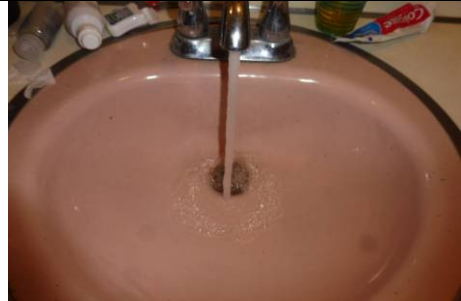
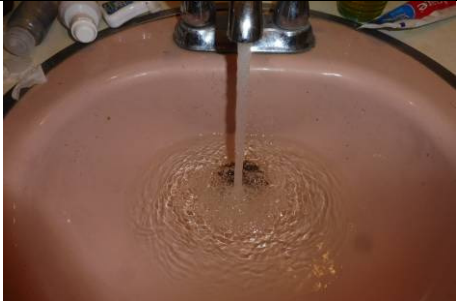
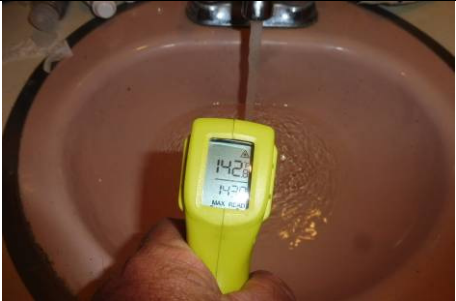
<b>Notice:</b> Water pressure running one fixture	<b>Notice:</b> Water pressure running multiple fixtures simultaneously	<b>Positive Attribute:</b> Hot water was obtained at <b>all</b> of the fixtures today.

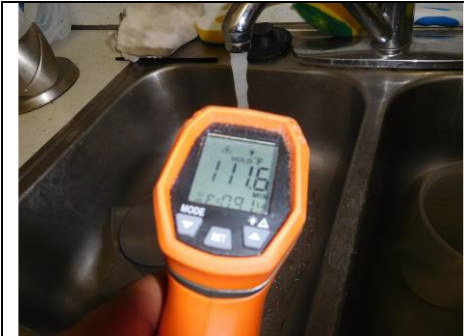
#12 ✓ Good Hot Water

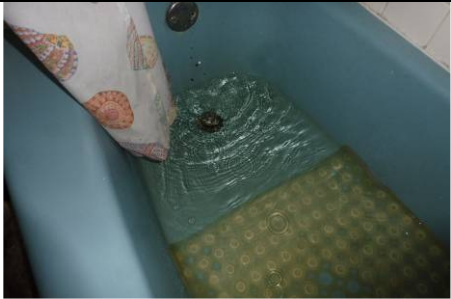
Slow draining plumbing fixtures

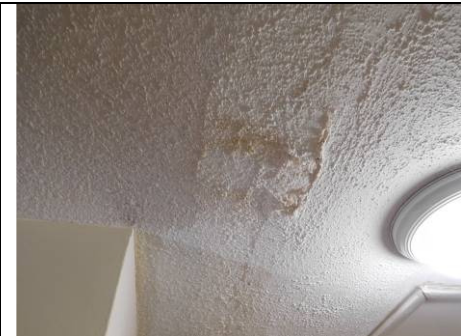
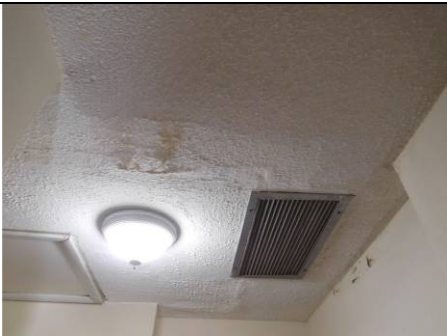
#11

- Investigate Further, Repair:** Water stains were observed. The stains tested wet with a moisture meter today. **LOCATION(S): Ceiling # 11, 10, 8 and 2 (beside air handler)**

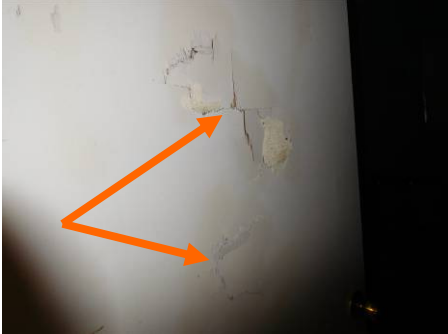
<p>Damaged door bedroom #5</p>	  <p>#6 Trap Suspect</p>	  <p>Water stain damage living room ceiling #1</p>
  <p>Damage Living room ceiling #3</p>
