Atlantic Building Inspections

Property Inspection Report

1234 SW 56 Place, Miami, FL 33333

Date of Inspection: 1/30/2020 Time: 9:00 AM

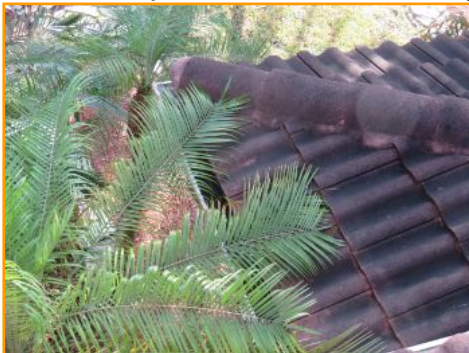
2.3. Improve: Tree trimming is recommended.

Trees Touching Roof

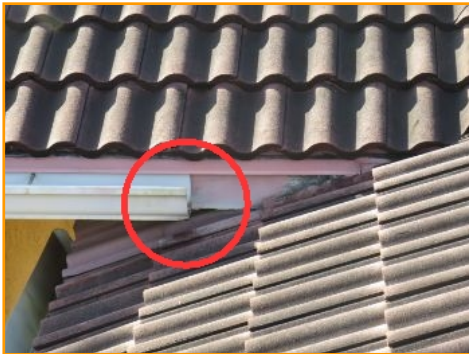
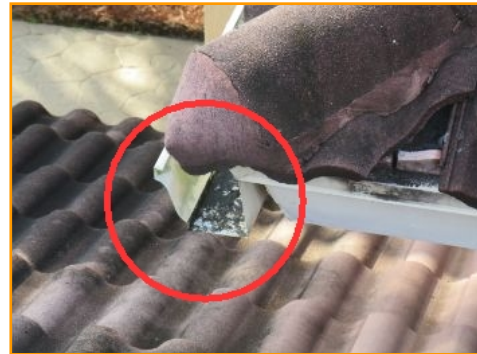
5.2. Repair: The roof gutters are leaking at one or more locations. Identify all locations and repair as needed.

Draining Onto Roof

*Approximate Costs: (low) +/- \$200 to (high) +/- \$300, depending on conclusions, approach and further evaluation by licensed contractors.

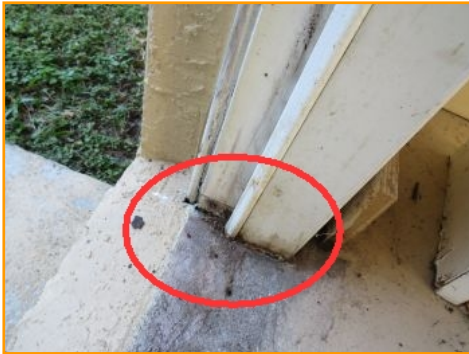
Water Damaged

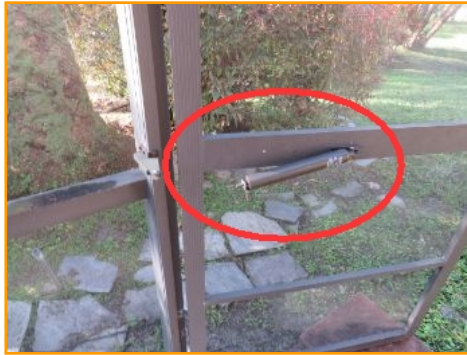
Damaged Door Strut

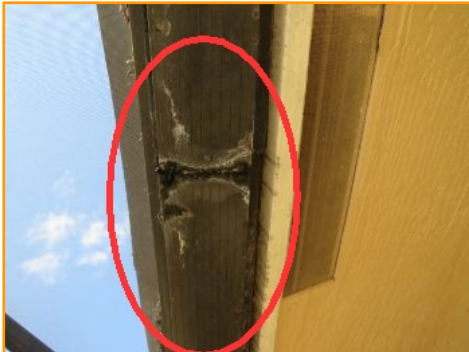
Damage

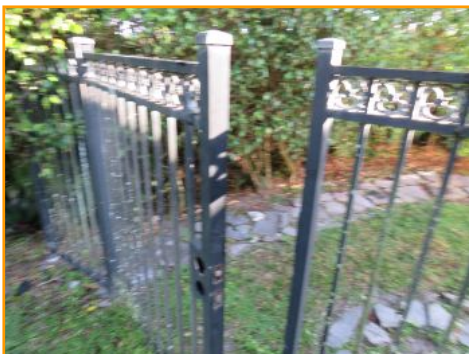
9.2. Safety Repair/Improvement: The side gates should be self-closing and child safety protective latches. Obtain estimates.

Not Self Closing

*Approximate Costs: (low) +/- \$200 to (high) +/- \$400 (per location), depending on conclusions, approach and further evaluation by licensed contractors.

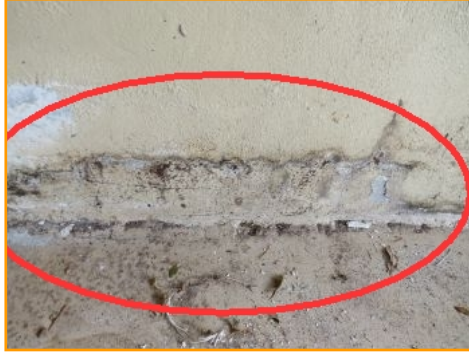
Moisture Stains

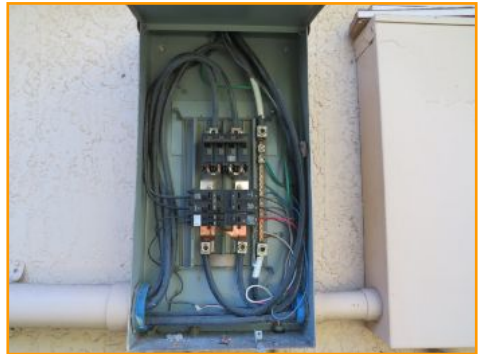
Panel Without Cover

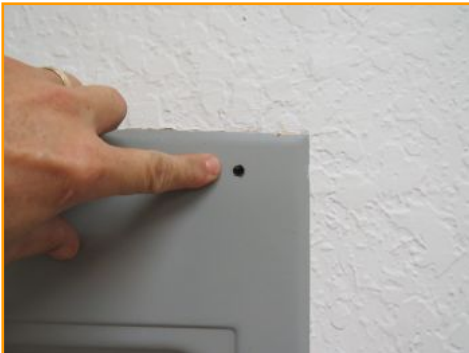
6.2. Safety Improvement: Two of the screws used for the panel cover are missing. Non-pointed screws should be used to secure the panel properly.

Missing Screws

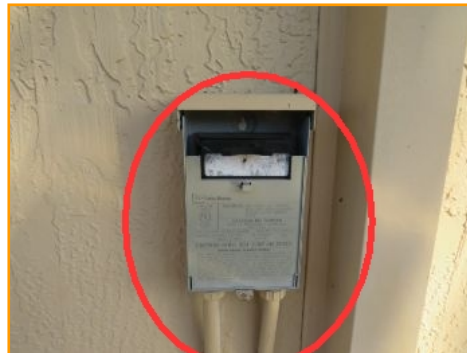
9.2. Replacement Item, Safety Concern: The dead front cover or inner cover is missing.

Missing Outer Cover

*Approximate Costs: (low) +/- \$75 to (high) +/- \$150 (per location), depending on conclusions, approach and further evaluation by licensed contractors.

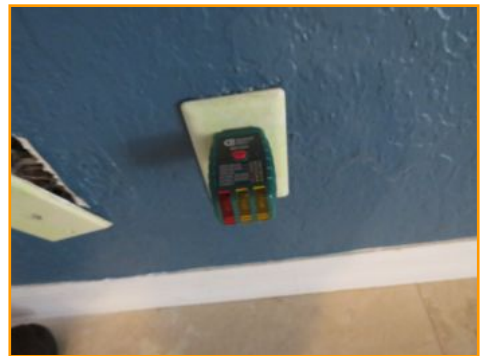
11.5. Repair/Replace: The outlet is inoperative (various locations throughout).

Inoperative

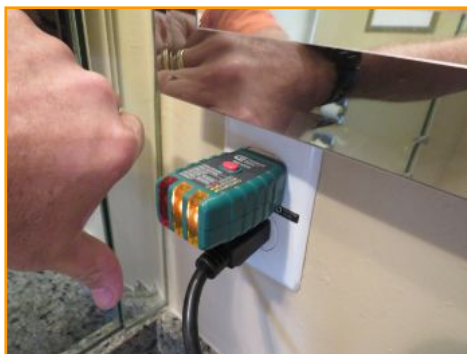
NO GFI Protection

11.4. Safety Improvement: The installation of a ground fault circuit interrupter (GFCI) is recommended at all appropriate locations. A ground fault circuit interrupter (GFCI) offers protection from shock or electrocution. Bathrooms

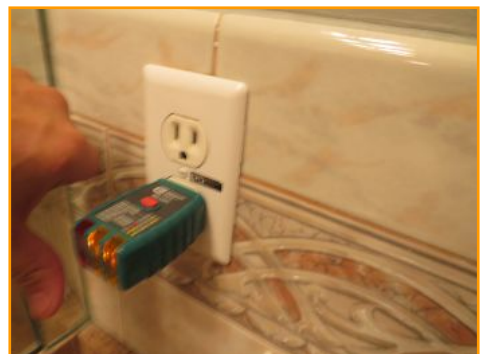
NO GFI Protection

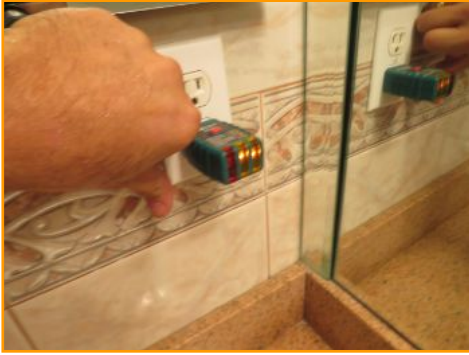
NO GFI Protection

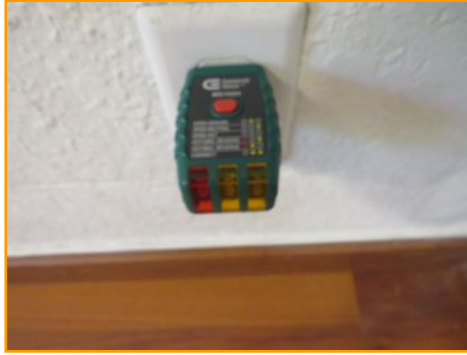
Inoperative

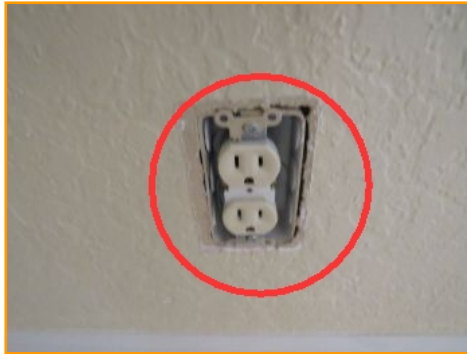
Missing Face Plate/Cover

11.2. Improve: Replace missing and or damaged outlet covers (various locations throughout).

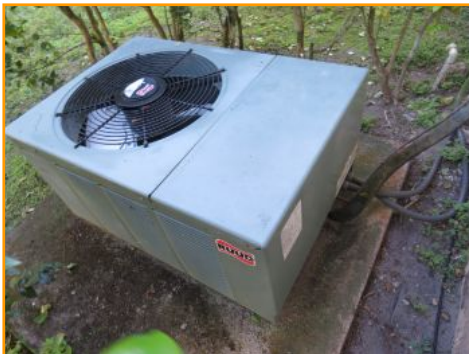
3.2. Monitor, Budget Item: The unit is very old. Based on the age of the unit, replacement should be anticipated in the short-term. The unit has exceeded its average estimated life span. A complete system replacement budget of \$ 3,000 / \$ 4,000 should be in place as the unit can malfunction, breakdown and/or discontinue proper operation at any moment and without warning. Weighing the cost and benefits of complete replacement in place of performing localized repairs is recommended. In some cases, it may be more cost effective to “replace” as an alternative to “repair”. The actual cost of the replacement unit will depend on the type, efficiency and brand name of the unit. Be aware that a change in the air conditioning industry will force replacement of the entire system. No longer can only the air handler or the condenser units be replaced individually. This will add costs to the job.

Condensing Unit

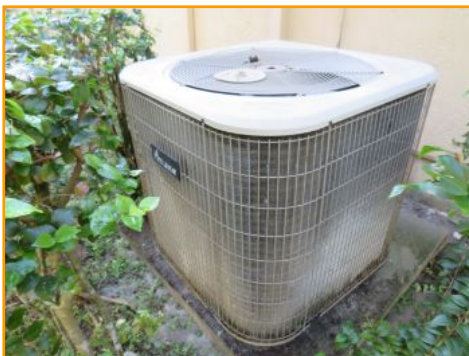
5.2. Monitor, Budget Item: The unit is very old. Based on the age of the unit, replacement should be anticipated in the short-term. The unit has exceeded its average estimated life span. A complete system replacement budget of \$ 3,000 / \$ 4,000 should be in place as the unit can malfunction, breakdown and/or discontinue proper operation at any moment and without warning. Weighing the cost and benefits of complete replacement in place of performing localized repairs is recommended. In some cases, it may be more cost effective to “replace” as an alternative to “repair”. The actual cost of the replacement unit will depend on the type, efficiency and brand name of the unit. Be aware that a change in the air conditioning industry will force replacement of the entire system. No longer can only the air handler or the condenser units be replaced individually. This will add costs to the job.

5.3. Improvements: The condensate line drains near the foundation wall and should be extended to discharge at least five feet away. The condenser coils are dirty and should be cleaned for the season. The condenser is not properly strapped or strapped at all. The refrigerant line insulation is damaged and should be replaced. The overgrown vegetation, around the condenser, should be cut back. The refrigerant line raceway should be properly sealed in order to prevent vermin activity.

Condensing Unit

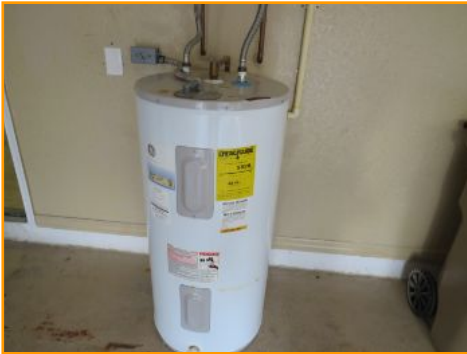
4.4. Investigate Further, Repair/Replace: The water heater #1 did not produce hot enough water today. Water Heater may have to be adjusted. Warm Water

*Approximate Costs: (low) +/- \$150 to (high) +/- \$200 for further investigation ONLY, depending on conclusions, approach and further evaluation by licensed contractors. In this case, specific estimates need to be obtained from licensed contractors.

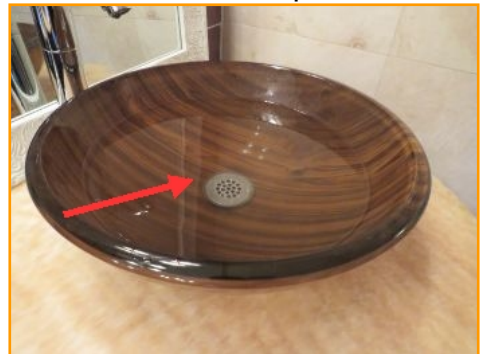
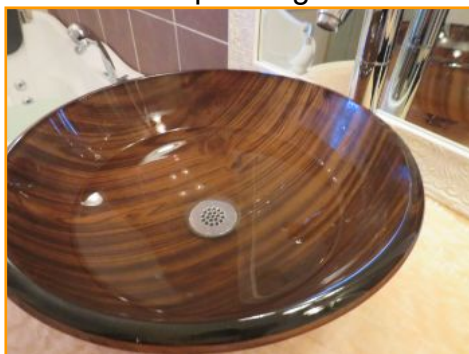
3.1. Improve: The sink was observed to drain slowly, suggesting that an obstruction may exist. In many cases, a good trap cleaning resolves this condition; however, preliminary cleaning may reveal more extensive blockage and the need for further repairs.

Drains Slowly

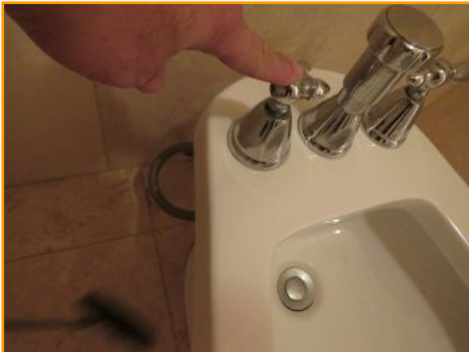
6.2. Repair: The faucet handle is damaged.

Damaged Handle

*Approximate Costs: (low) +/- \$225 to (high) +/- \$350 (per location), depending on conclusions, approach and further evaluation by licensed contractors.

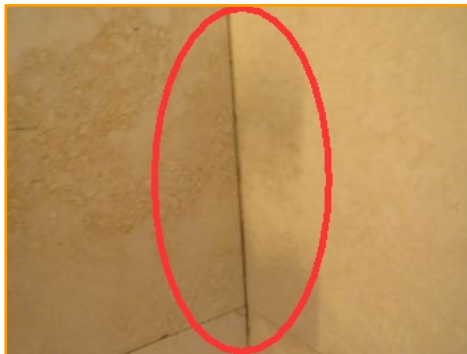
2.2. Improve: The tile shower stall requires improvement. Damaged grout and caulk should be improved or replaced as necessary. Any damage to the wall behind the tile should also be repaired (if necessary).

Deteriorated Grout

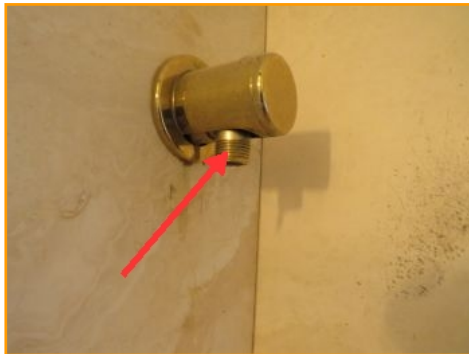
2.3. Replace: The shower flex hose is missing.

Missing Shower Hose

*Approximate Costs: (low) +/- \$125 to (high) +/- \$175 (per location).

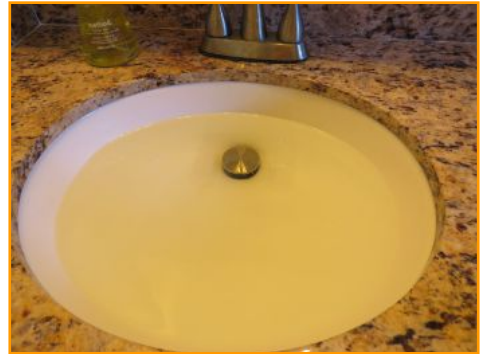
3.3. Improve: The sink was observed to drain slowly, suggesting that an obstruction may exist. In many cases, a good trap cleaning resolves this condition; however, preliminary cleaning may reveal more extensive blockage and the need for further repairs.

Drains Slowly

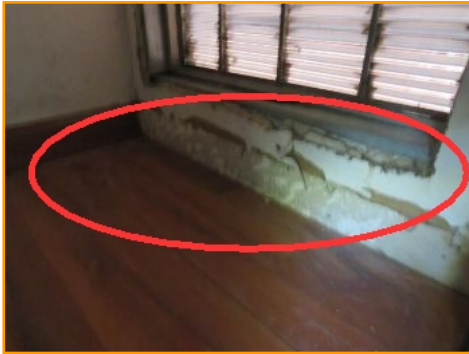
Moisture Damaged

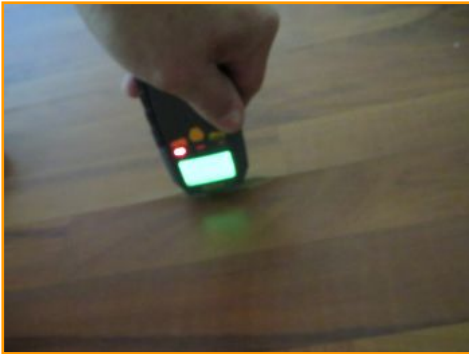
2.4. Investigate Further, Repair: Water stains were observed (guest bedroom)front. The stains tested WET with a moisture meter today.

Wet Moisture Readings

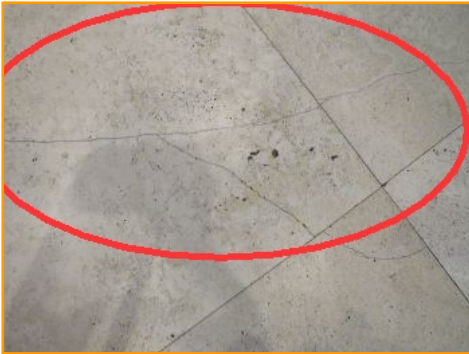
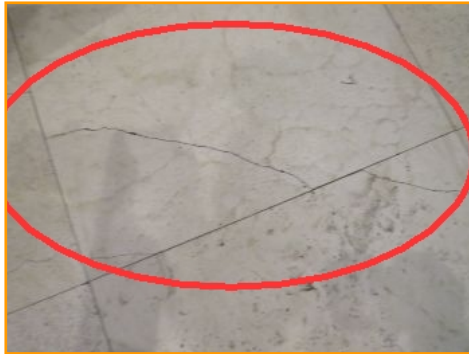
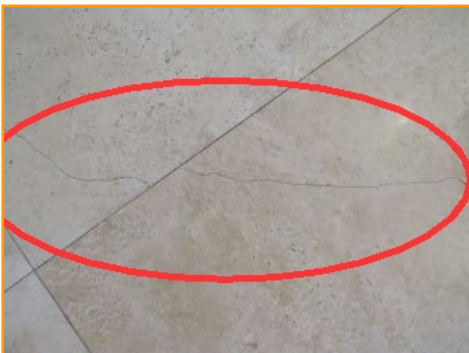
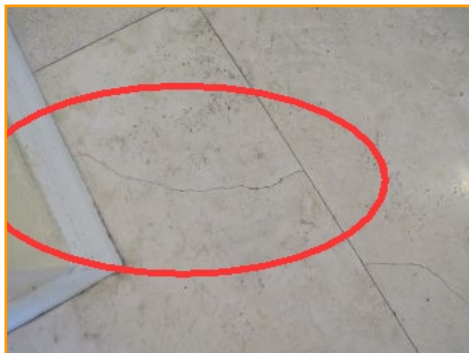
2.2. Investigate Further, Possible Repair: The tile floor is cracked (kitchen)living room. The cracks appear to be beyond cosmetic and further, more exploratory, investigation may reveal a more serious condition below the finished flooring.

Cracks

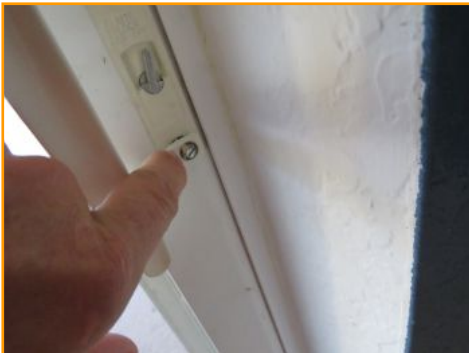
3.2. Repair/Replace: Door handle is damaged/loose.
Living Room & Master Bedroom

Loose Door Handle

Loose/Damaged Door Handle

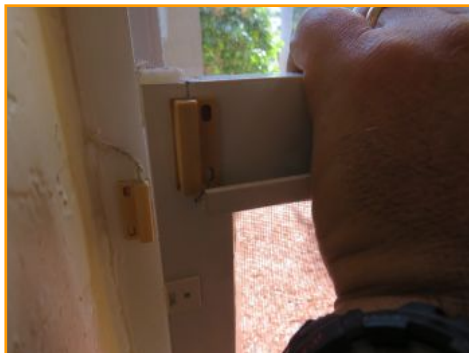
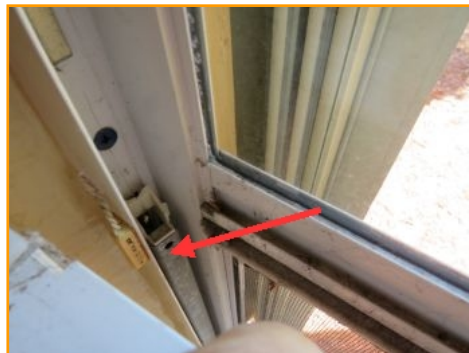
4.6. Safety Repair: The window springs/tension rods are damaged and the window closes abruptly (Dining Room). Care must be taken when operating the windows.

Damaged Springs/Tension Rods

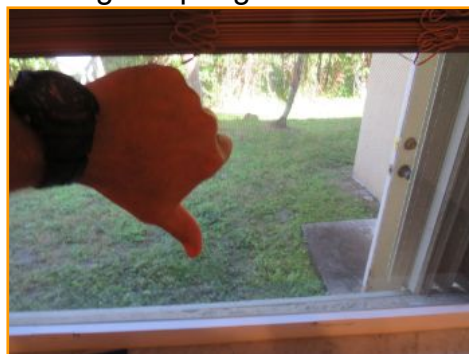
4.2. Repair: The window does not open and or close properly or at all (guest bedroom).

Inoperable

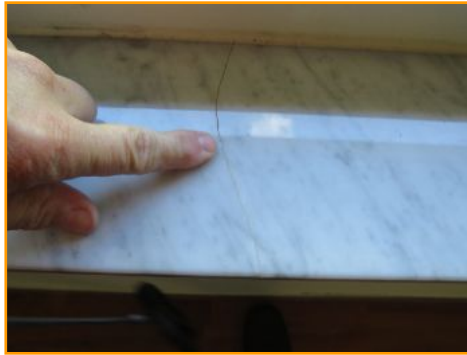
4.5. Replace/Repair: The window sill is damaged and in need of repair or replacement (master bedroom) Guest Bedroom.

Damaged Window Sill

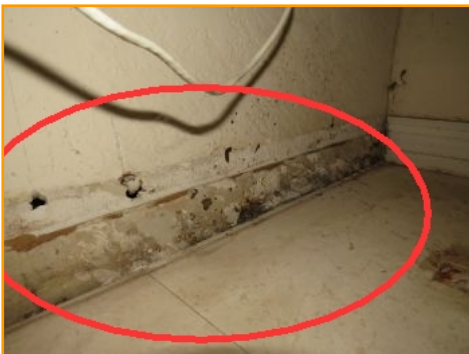
5.1. Investigate Further, Possible Repair: Evidence of, what appears to be, mold was observed (air handler closet)A/C #2. Mold detection is outside the scope of this inspection; however, it should be noted that not all molds are harmful and only laboratory testing can determine the type of mold, if any. The accessible area(s) tested dry with a moisture meter today. Mold testing is recommended. Ask the seller to disclose any historical data regarding mold. Consult a licensed mold assessor, before the end of your inspection period, for mold sampling. Atlantic Building Inspections is a State Licensed Mold Assessor (call the office if you wish to schedule a mold sampling). *the cost summary provided is for sampling/testing ONLY. Obtain remediation costs from a licensed mold remediator after obtaining laboratory analysis results.

Apparent Mold Like Substance

*Approximate Costs: (low) +/- \$350 to (high) +/- \$UNKNOWN (for MOLD testing ONLY), depending on conclusions, approach and further evaluation by licensed contractors.

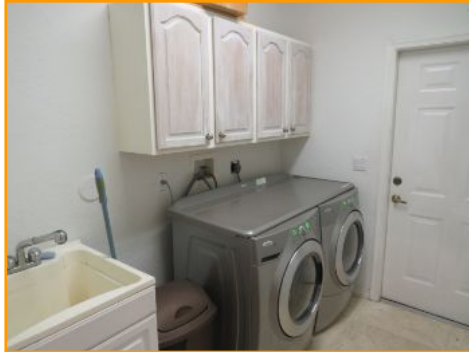
1.1. *Positive Attributes: The cabinets are in, generally, good condition.

Laundry Cabinets/Counters

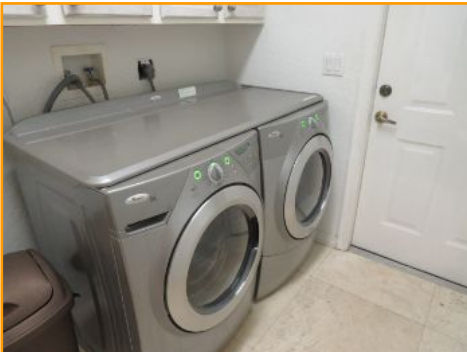
2.1. *Positive Attributes: The dryer operated with normal controls today.

Washer & Dryer

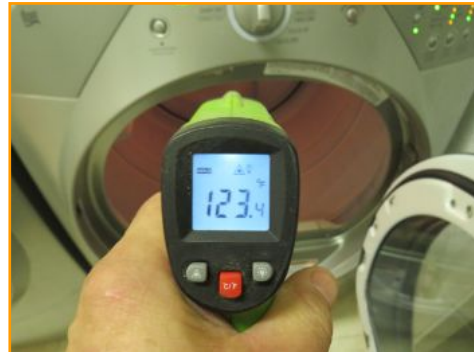
Temperature Reading

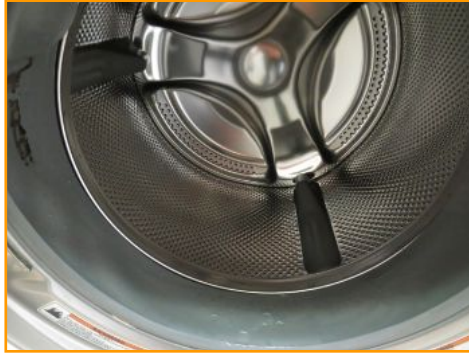
3.2. *Positive Attributes: The washer appeared to operate with normal controls today. This is a front loading unit, which does not allow for testing of water temperature or intermittent inspections of the unit as it goes through all cycles to ensure proper functioning. The washer was started at the commencement of the property inspection and checked again at the conclusion. It appears that all cycles performed as intended; however, this could not be determined with a complete degree of certainty. We do recommend that the current owner demonstrate proper function of the unit before closing the sale of the property.

Empty - Completed Cycle

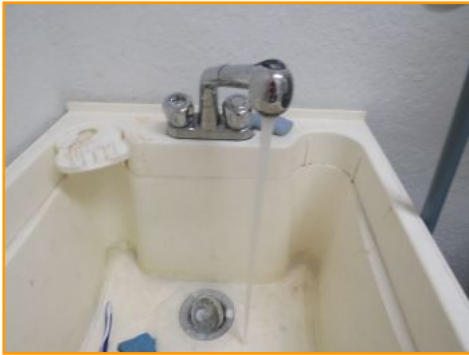
4.1. *Positive Attributes: The sink(s) operated as intended.

Good Water Pressure

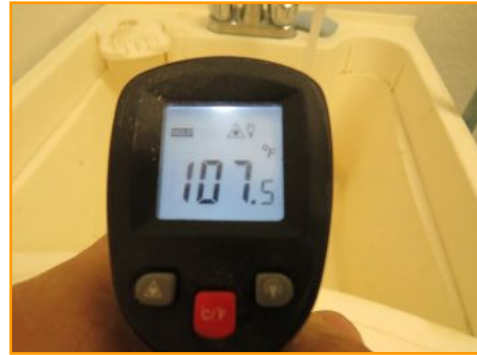
Hot Water Temperature

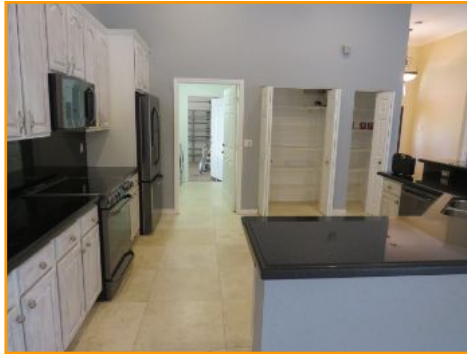
- 1.1. *Positive Attributes: All the appliances tested today operated with normal controls.
- 1.2. *Positive Attributes: The kitchen appears to be in, generally, good/satisfactory working order.

General Kitchen

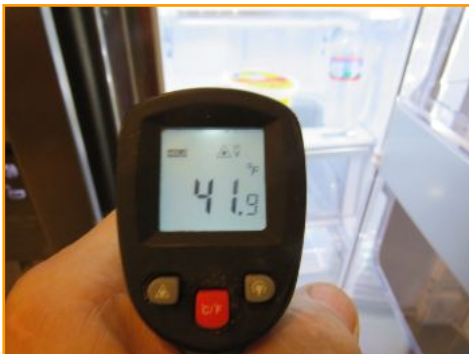
- 2.1. *Positive Attributes: The refrigerator/freezer operated as intended and “normal” temperatures were recorded today (ice makers, water dispensers and other features are outside the scope of this inspection).

Refrigerator

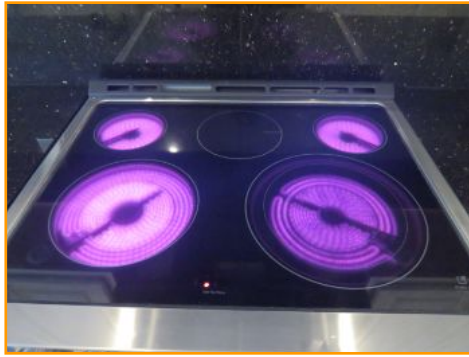
- 3.1. *Positive Attributes: All heating elements operated when tested.

Range

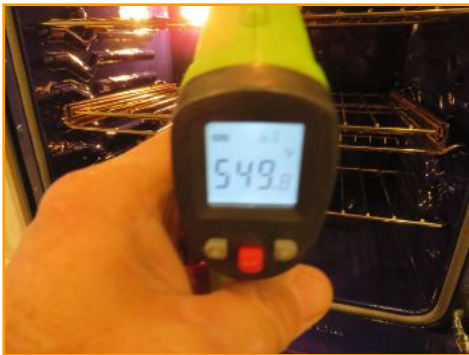
Broiler

4.1. *Positive Attributes: Oven(s) operated when tested.

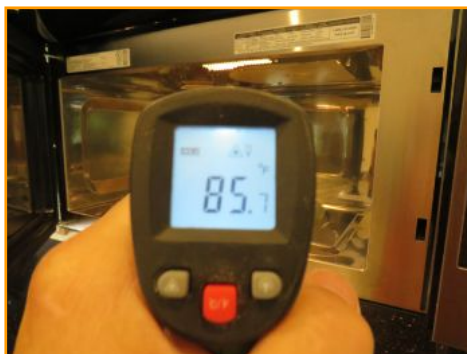
5.1. *Positive Attributes: Built-in microwave ovens are tested using normal operating controls. Unit was tested and appeared to be serviceable at time of inspection. Leak and/or efficiency testing is beyond the scope of this inspection. If concerned, client should seek further review by qualified technician prior to closing.

Microwave

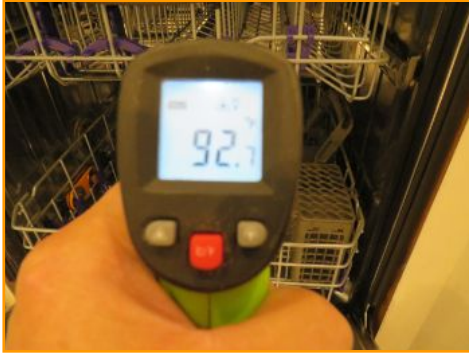
6.1. *Positive Attribute: The unit operated with normal controls today. Dishwashers most commonly fail internally at the pump, motor or seals. We do not disassemble these units to inspect these components. We recommend you operate this unit prior to closing.

Dishwasher

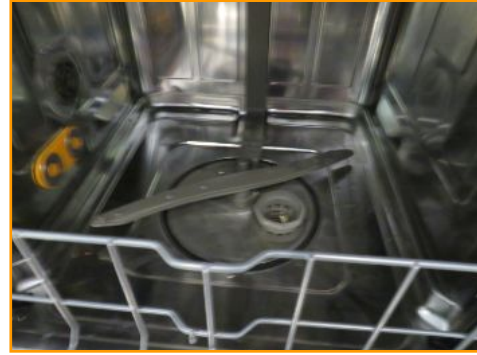
Empty- Completed Cycle

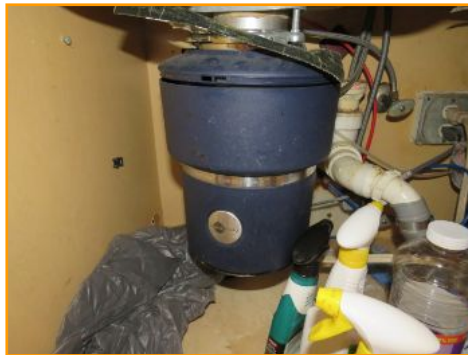
7.1. *Positive Attribute: Operated - appeared functional at time of inspection.

Garbage Disposal

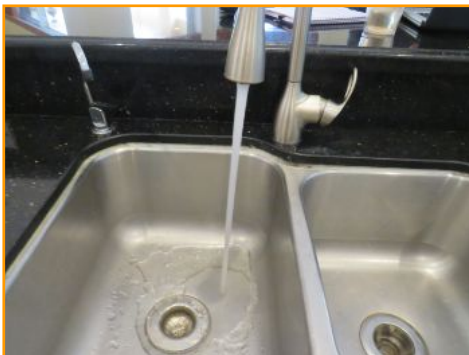
8.1. *Positive Attributes: The sink(s) operated as intended.

Good Water Pressure

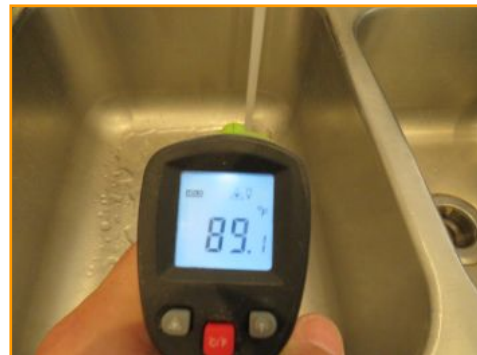
Warm Water Temperature

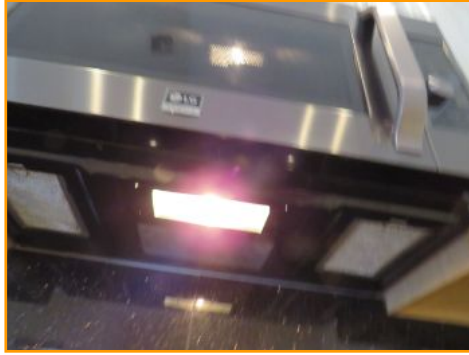
9.1. *Positive Attributes: The unit operated with normal controls today.

Vent Condition

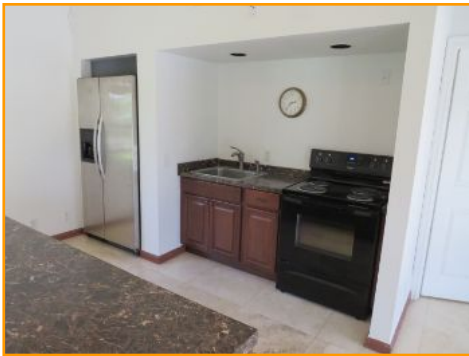
- 1.1. *Positive Attributes: All the appliances tested today operated with normal controls.
- 1.2. *Positive Attributes: The kitchen appears to be in, generally, good/satisfactory working order.
- 1.3. Repair/Replace: The cabinets are water or physically damaged and are in need of repair or possible replacement.
- *Approximate Costs: (low) +/- \$500 to (high) +/- \$2500++, depending on conclusions, approach, material used, and further evaluation by licensed contractors.

In Laws Quarters Kitchen General Kitchen

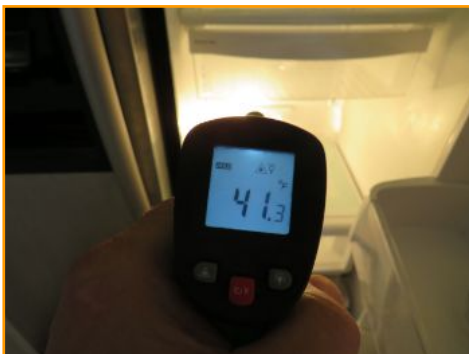
- 2.1. *Positive Attributes: The refrigerator/freezer operated as intended and "normal" temperatures were recorded today (ice makers, water dispensers and other features are outside the scope of this inspection).

In Laws Quarters Kitchen Refrigerator

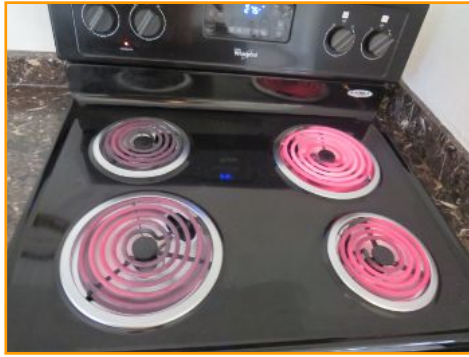
- 3.1. *Positive Attributes: All heating elements operated when tested.

In Laws Quarters Kitchen Range

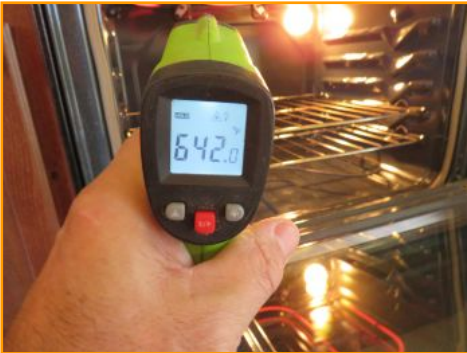
Broiler

4.1. *Positive Attributes: Oven(s) operated when tested.

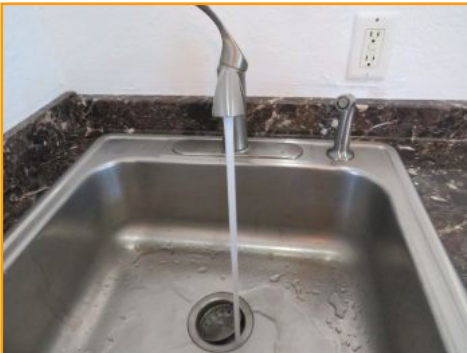
5.1. *Positive Attributes: The sink(s) operated as intended.

Good Water Pressure

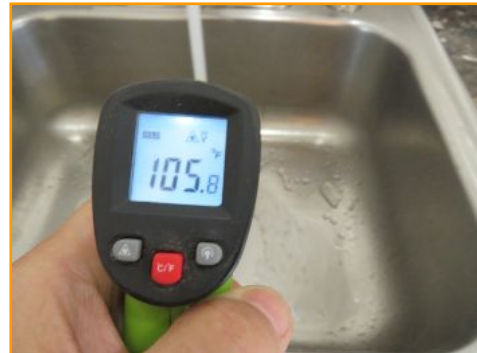
Hot Water Temperature
