Atlantic Building Inspections

Property Inspection Report

SAMPLE REPORT

Date of Inspection: 1/18/2022 Time: 9:00 AM

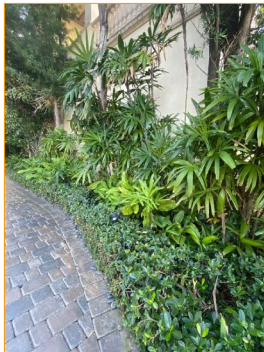
4.2. Limitation: Due to heavy vegetation and or planters, the foundation walls were not fully visible/accessible. This restricted the inspection.

Restricted Visibility

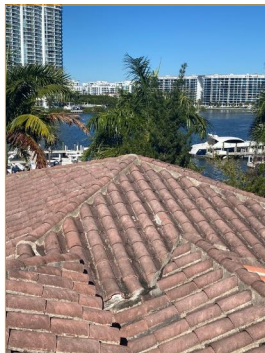
Roof

2.1. Significant Budget Item: An online BuildFax permit record search shows the roof was installed in 2003. This type of covering has an approximate estimated life span of 20-25 years +/- with frequent monitoring and maintenance. The visible roof coverings are old, deteriorating and in, generally, declining condition. In conclusion, the visible roof coverings are very near the end of their useful and serviceable life. Ideally, the roof should be replaced; however, repairs and preventative maintenance may prolong the life of the roof. In many cases replacing the roof coverings now will be more cost effective then performing repairs.

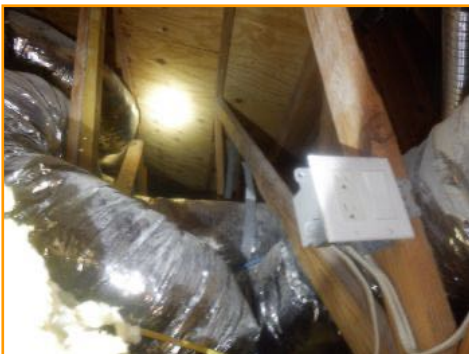
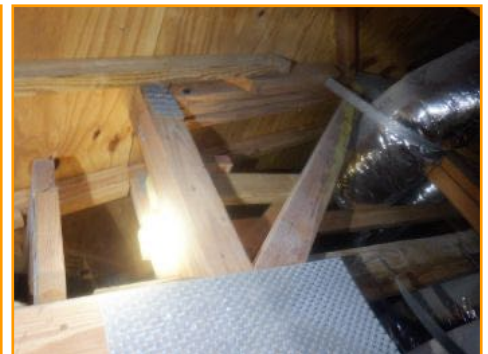
Attic

5.2. Limitation: Entering and maneuvering the attic space was not possible today. The attic was viewed from the access hatch. This restricted the inspection.

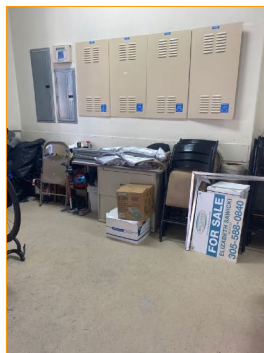
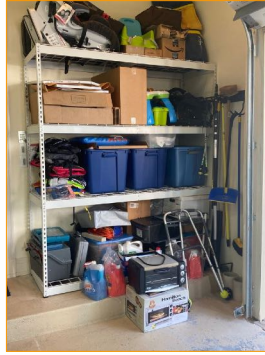
4.1. Limitation: Stored items prevented complete evaluation of the garage walls, floors, ceilings, windows and doors. This restricted the inspection. Perform a property walkthrough before closing.

Stored Items

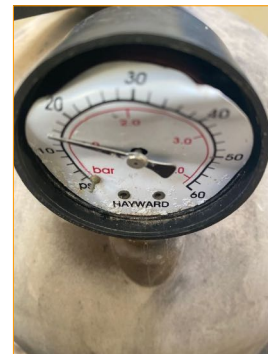
5.1. Repair: The filter gauge is damaged and or did not operate at the time of the inspection.

Filter Gauge

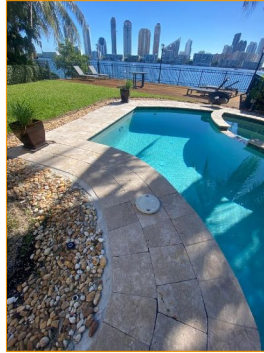
Deck

6.2. Safety Improvement: The pool deck presents a tripping hazard.

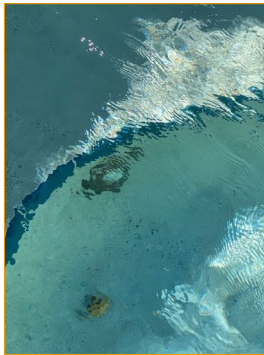
11.1. Repair: The spa lights were inoperative at the time of inspection.

Lights Inoperative

*Approximate Costs: (low) +/- \$250 to (high) +/- \$550, depending on conclusions, approach and further evaluation by licensed contractors.

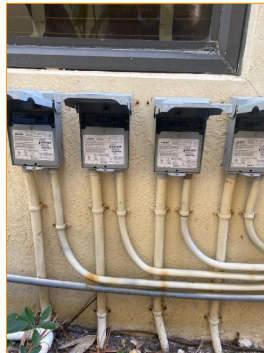
Air conditioner disconnect panels

7.1. *Positive Attributes: The **A/C** disconnect panel(s) appears to be in, generally, good condition.

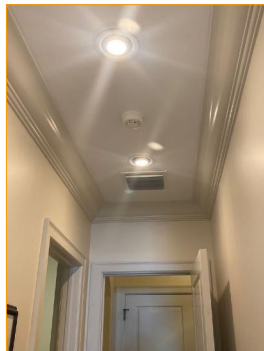
Smoke Detectors Present

12.1. Limitation, Notice: One or more smoke detectors were present today; however, smoke detectors are not tested as part of this visual inspection. It may be recommended that additional units be added in all appropriate locations (this does not mean you need more; however, more units may be recommended). It would be wise to have the seller demonstrate proper function of all detectors. Installing smoke and carbon detectors (if there are gas appliances), in all appropriate locations, is strongly recommended.

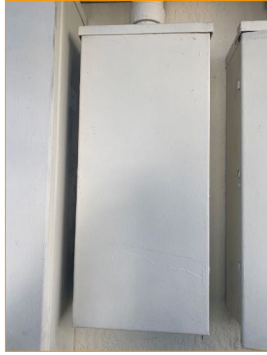
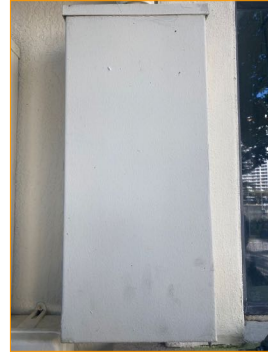
Cover Not Removed

13.1. Limitation: The cover of one or more electrical panel(s) could not be removed today as they are heavily painted over and covers are "stuck". This restricted the inspection.

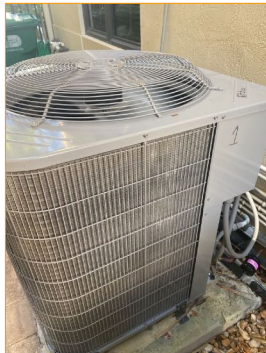
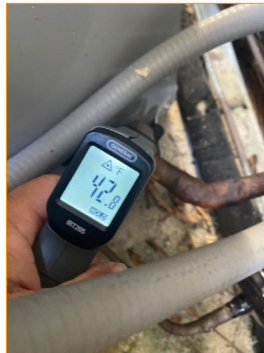
Air Conditioner 1

1.1. *Positive Attributes: The air conditioning systems operated with normal controls today and are functioning as intended (cooling cycle).

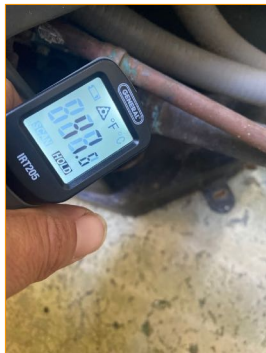
Air Conditioner 2 return temperature

1.4. Significant Replacement Item: Units 2 and 3 are very old (obsolete). Based on the age, replacing the entire air conditioning systems is advisable in the near future. (interior and exterior units). Replacing the systems is more cost effective than performing any repairs.

*Approximate Costs: (low) +/- \$3,500 to (high) +/- \$5,500, depending on type, name brand, size, conclusions, approach and further evaluation by licensed air conditioning contractors.

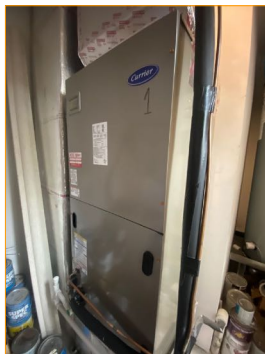
Air Handler 1 (2021)

2.3. Positive Attributes: Units 1 and 4 are relatively newer. Regular maintenance will, of course, be necessary.

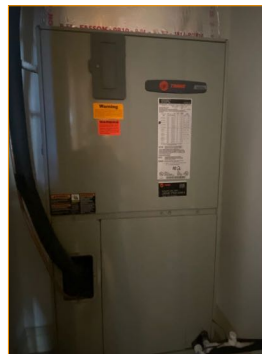
Air Handler 2 (2003)

2.4. Monitor, Budget Item: Units 2 and 3 are older. Based on the age of the units, replacement should be anticipated in the short-term. The units have or are close to exceeding their average estimated life span. A complete system replacement budget of \$ 3,500± / \$ 5,500± should be in place as the unit can malfunction, breakdown and/or discontinue proper operation at any moment and without warning. The actual cost of the replacement unit will depend on the type, efficiency and brand name of the unit. Be aware that a change in the air conditioning industry will force replacement of the entire system. No longer can only the air handler or the condenser units be replaced individually. This will add costs to the job.

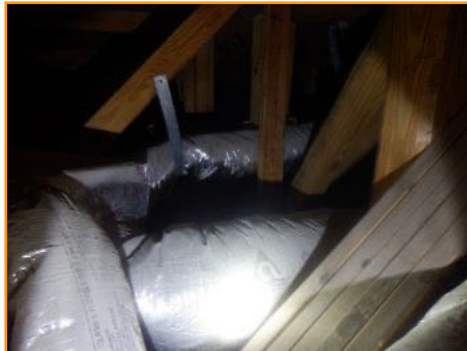
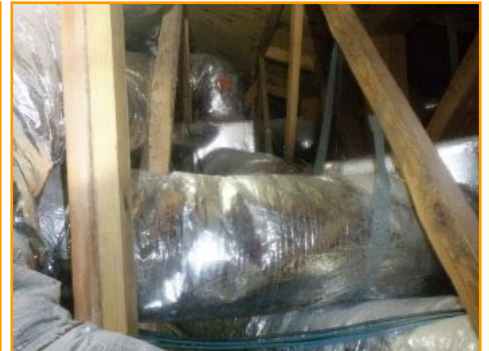
Ducts

3.1. *Positive Attributes: The visible ductwork, in the accessible areas of the property appear to be in, generally, satisfactory/good condition.

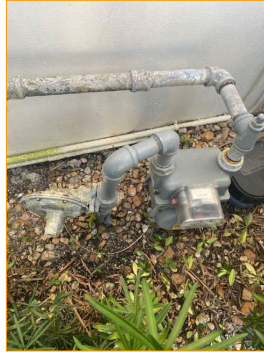
Gas meter

2.1. *Positive Attributes: The gas appliances operated as intended today. Note: Gas pipes are not visible or inspected during the course of this inspection.

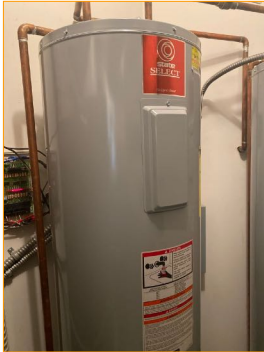
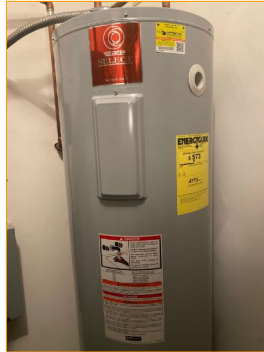
1.2. *Positive Attribute: The water heaters are new or relatively newer and should have remaining useful and serviceable life. Ask the seller to provide any applicable warranties for the unit. Hot water was obtained at all of the fixtures throughout the property today.

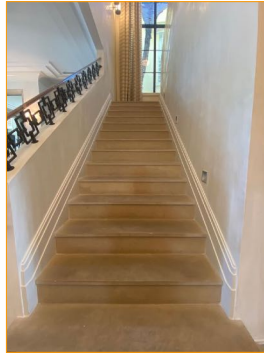
Stairs

6.1. *Positive Attributes: The accessible/visible staircase and railings are in, generally, satisfactory/good condition.

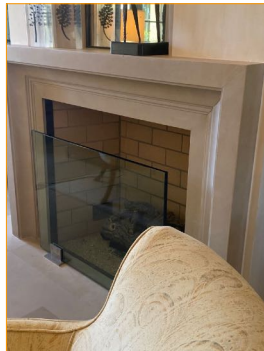
Out of scope

7.1. Limitation: The fireplace and chimney are outside the scope of this inspection.

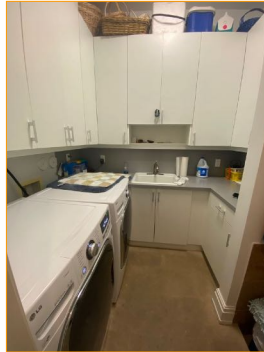
Cabinets

1.1. *Positive Attributes: The cabinets are in, generally, good condition.

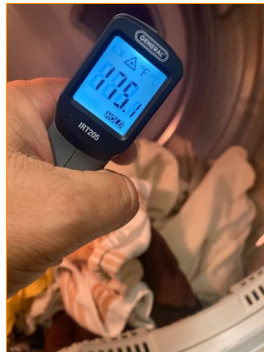
2.1. *Positive Attributes: The dryer operated with normal controls today.

Operated as Intended

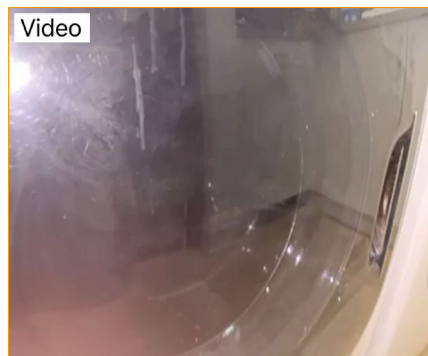
3.1. *Positive Attributes: The washer operated with normal controls today.

Operated as Intended

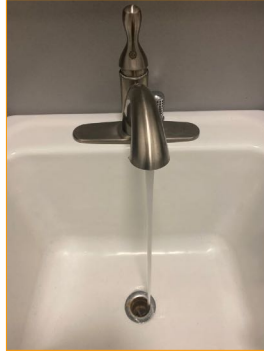
4.1. *Positive Attributes: The sink(s) operated as intended.

Operated as Intended

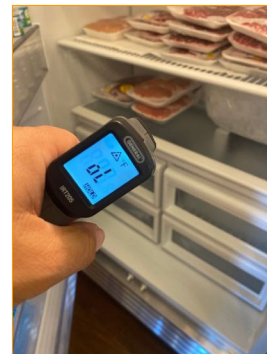
Freezer temperature

2.2. Budget Item: The refrigerator/freezer is very old. Normally refrigerators last about 9-13 years. Replacement is imminent. Note on life expectancy: Based on InterNACHI's Estimated Life Expectancy Chart for Florida Homes.

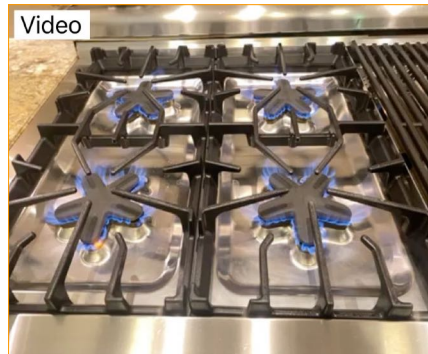
3.1. *Positive Attributes: All the range heating elements operated when tested.

3.2. Budget Item: Older unit. Normally stoves/ovens last about 13-17 years. Replacement is imminent. Note on life expectancy: Changed from 15-20 years based on InterNACHI's Estimated Life Expectancy Chart for Florida Homes. Electric (13-15 years), Gas (15-17 years)

Operated as intended

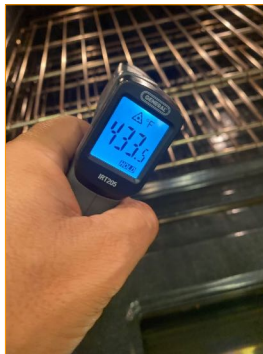
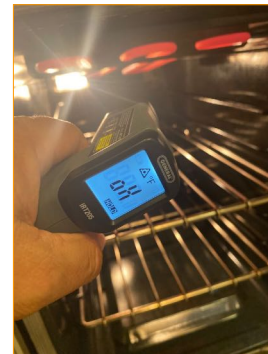
4.1. *Positive Attributes: Oven(s) operated when tested.

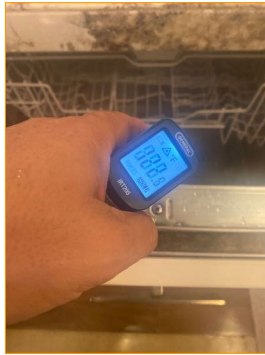
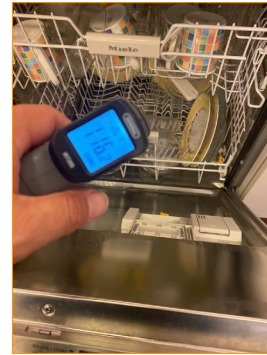
5.1. *Positive Attribute: The units operated with normal controls today. Dishwashers most commonly fail internally at the pump, motor or seals. We do not disassemble these units to inspect these components. We recommend you operate this unit prior to closing.

5.2. Budget Item: The dishwasher appears to be an older unit, and may have reached the end of its useful life. Normally dishwashers last about 9 years. Note on life expectancy: based on InterNACHI's Estimated Life Expectancy Chart for Florida Homes.

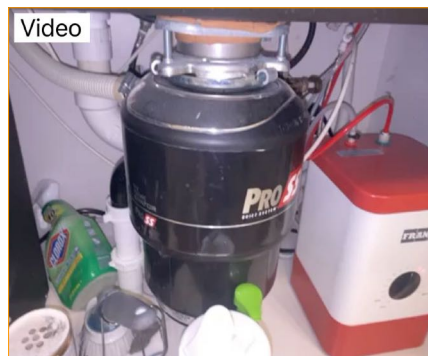
6.1. *Positive Attribute: Operated - appeared functional at time of inspection.

Operated as Intended

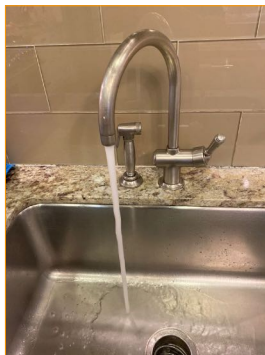
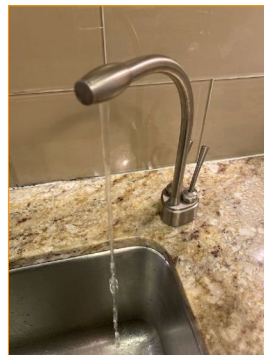
7.1. *Positive Attributes: The sink(s) operated as intended.

Operated as Intended

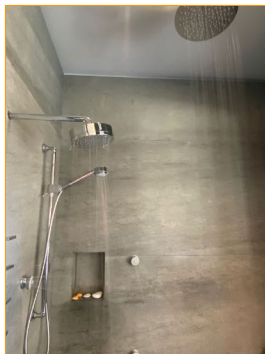
Operated as intended

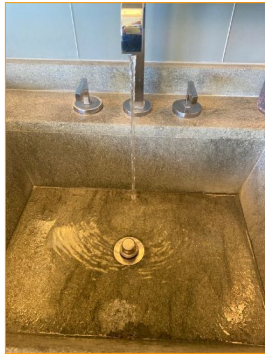
Right side sink

3.1. *Positive Attributes: The sink(s) operated as intended.

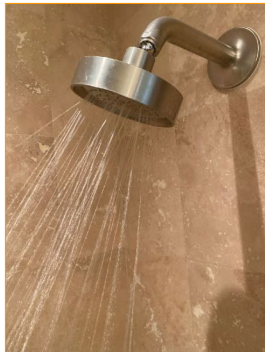
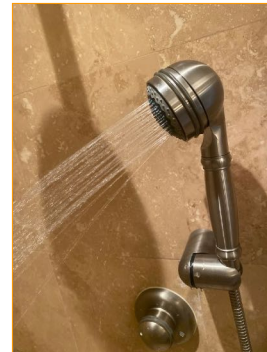
2.1. *Positive Attributes: The shower(s) operated as intended.

Operated as intended

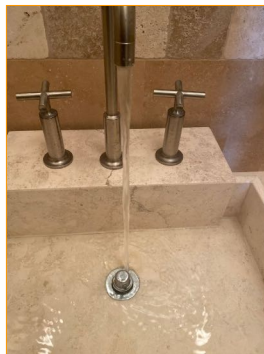
3.1. *Positive Attributes: The sink(s) operated as intended.

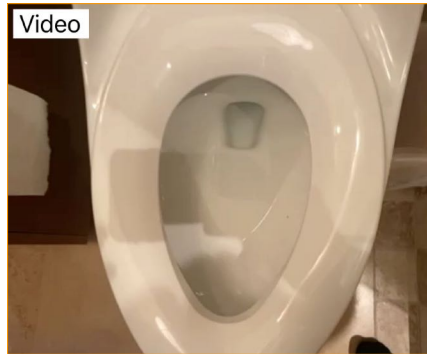
4.1. *Positive Attributes: The toilet(s) operated as intended.

Operated as Intended

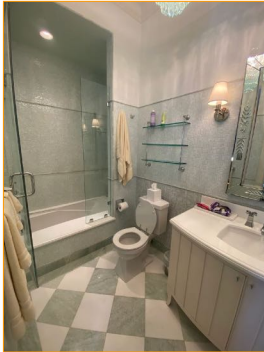
Bathroom

1.2. Repair/Replace: The bathroom vanity, cabinets, counter-tops or inner cabinet is water or physically damaged and in need of repair or replacement.

*Approximate Costs: (low) +/- \$850 to (high) +/- \$2500, depending on conclusions, type, material used, style, approach and further evaluation by licensed contractors.

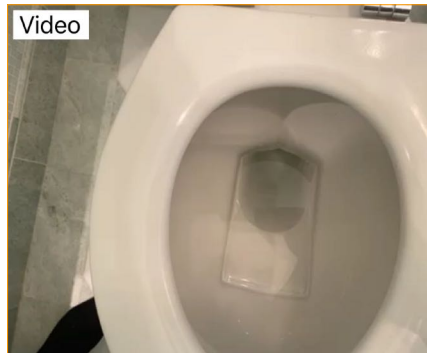
4.1. *Positive Attributes: The toilet(s) operated as intended.

Operated as Intended

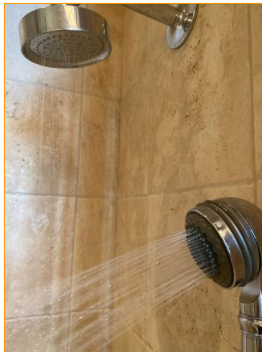
2.1. *Positive Attributes: The shower(s) operated as intended.

Operated as intended

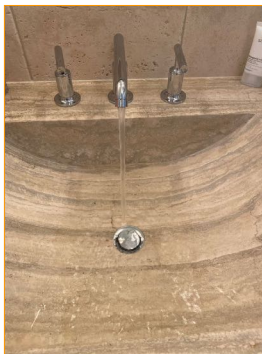
3.1. *Positive Attributes: The sink(s) operated as intended.

Operated as intended

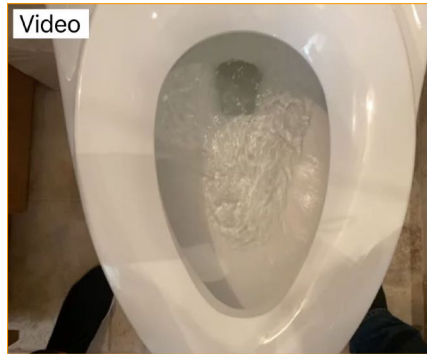
4.1. *Positive Attributes: The toilet(s) operated as intended.

Operated as Intended

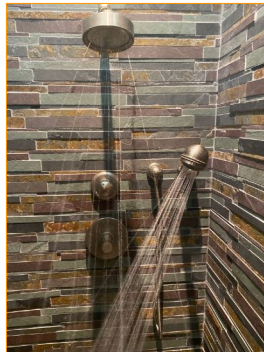
2.1. *Positive Attributes: The shower(s) operated as intended.

Operated as intended

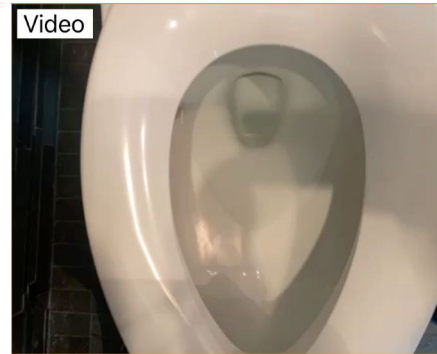
Toilet Operated

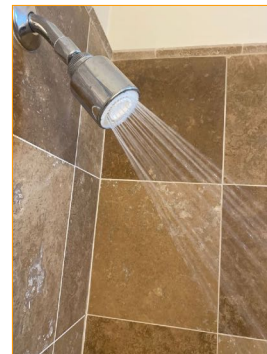
Showerhead Operated

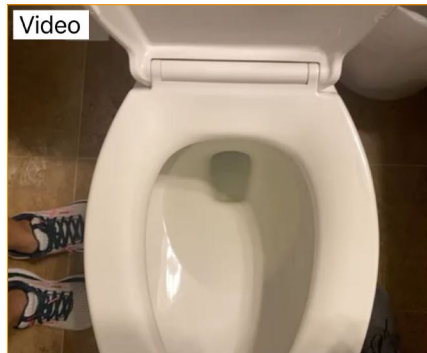
4.1. *Positive Attributes: The toilet(s) operated as intended.

Operated as Intended

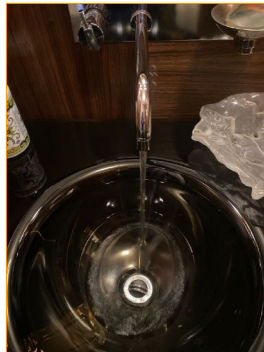
2.1. *Positive Attributes: The sink(s) operated as intended.

Operated as intended
