## Atlantic Building Inspections, Inc.

### HOME INSPECTION - INCLUDES WIND MITIGATION AND 4-POINT INSPECTION

100 Sample Avenue  
Sample City, FL 00000

INSPECTION DATE  
**September 17, 2026**

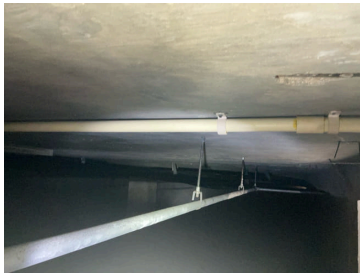
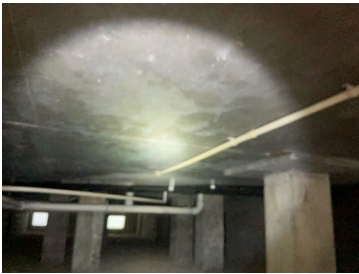
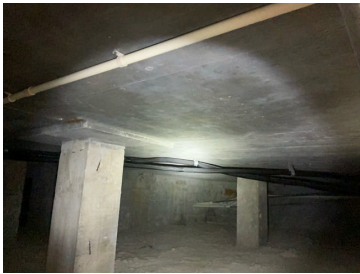
2.3.1 · Foundation

- ✓ Concrete

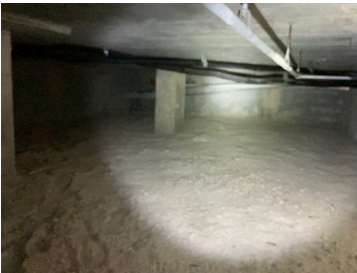
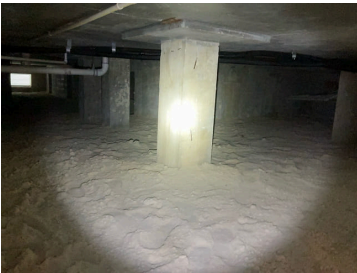
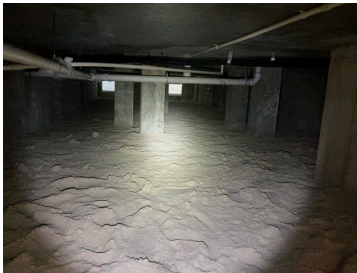
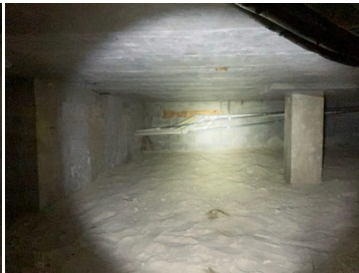
The visible crawlspace area appears to be in, generally, satisfactory/good condition.

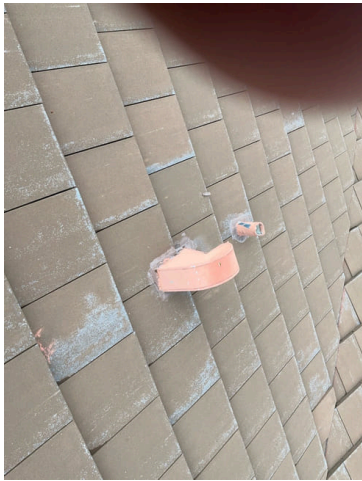
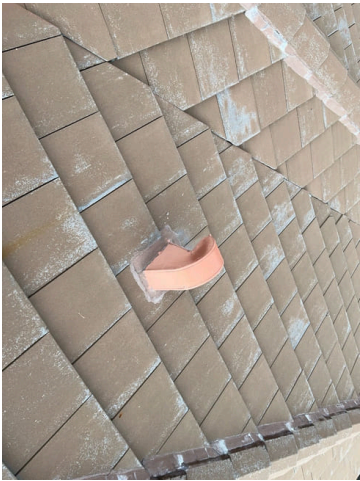
3.4.1 · Flashing

The visible flashings are or appear to be in, generally, satisfactory/good condition. Ask the seller to provide any warranty information.

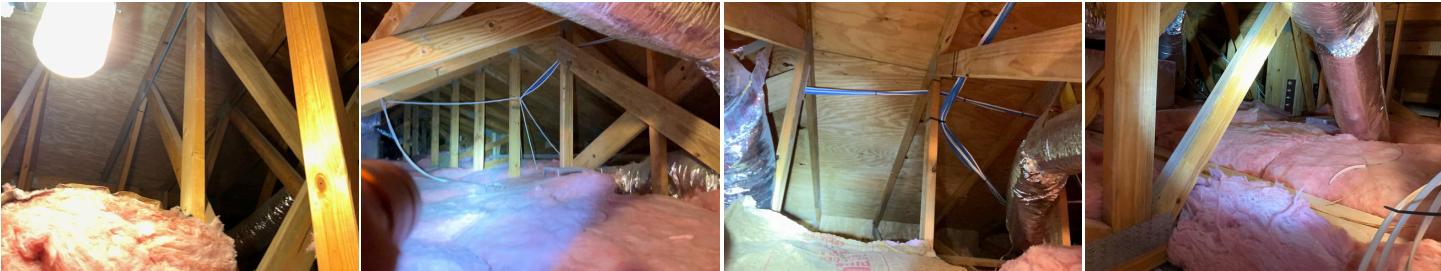
3.8.1 - Attic

The visible attic space appears to be in, generally, satisfactory/good condition.

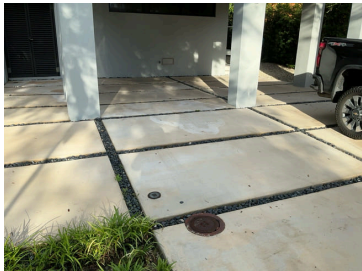
The visible driveway surface appears to be in, generally, satisfactory/good condition.

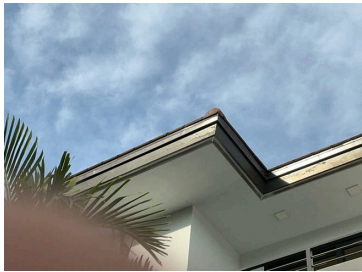
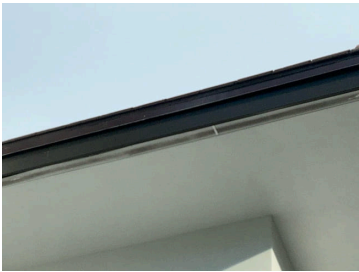
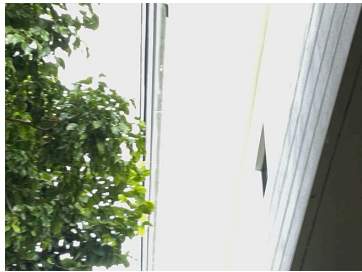
The visible exterior eaves appear to be in, generally, satisfactory/good condition (keep in mind this is a visual inspection only).

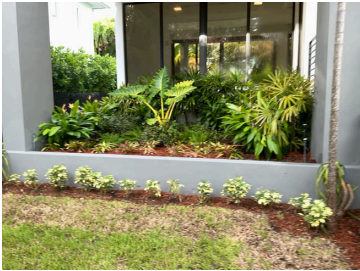
The visible planter walls (from the exterior of the planter) appear to be in, generally, good condition.

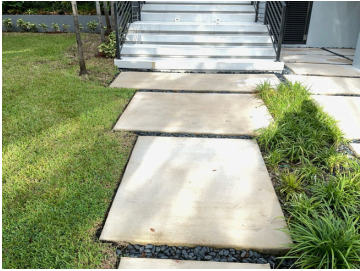
4.9.2 · Walkways

The walkway surfaces appear to be in, generally, satisfactory/good condition.

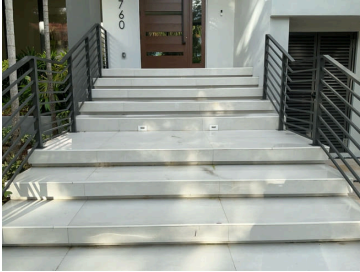
4.12.2 · Stairways

The accessible/visible staircase and railings are in, generally, satisfactory/good condition.

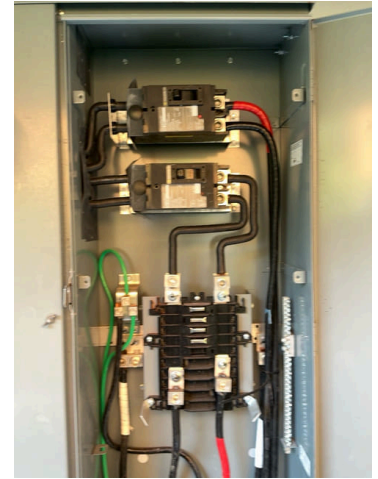
5.2.4 · Main Panel #1

The electrical panel is arranged well, and all breakers are properly sized.

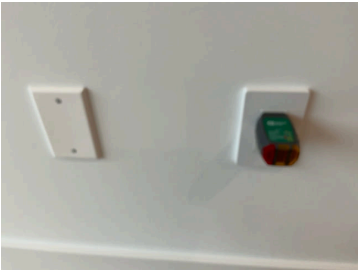
Master bedroom

Repair/Replace: The outlet is inoperative. <> \*Approximate Costs: (low) +/- \$175 to (high) +/- \$225 (per location), depending on conclusions, approach and further evaluation by licensed electricians.

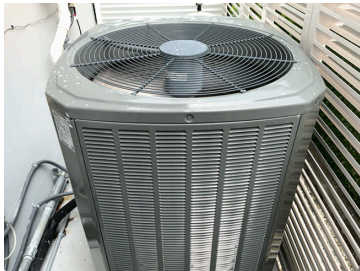
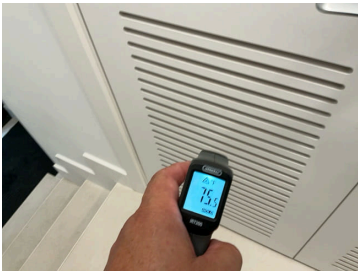
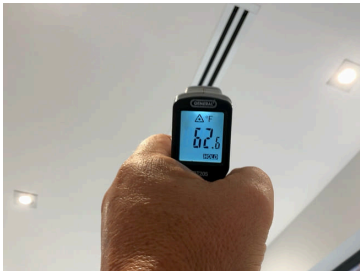
6.1.1 · Air Conditioner

Positive Attributes: The unit is relatively newer and appears to have been maintained well. Regular maintenance will, of course, be necessary.

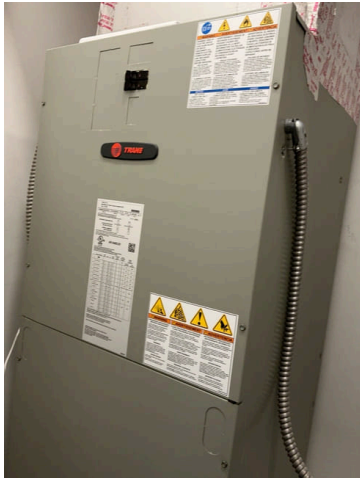
6.2.1 · Air Handler

Positive Attributes: The unit is relatively newer. Regular maintenance will, of course, be necessary.

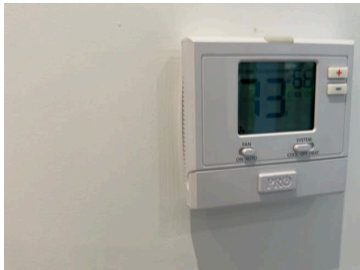
6.3.2 · Thermostat(s)

The thermostat(s) operated properly today.

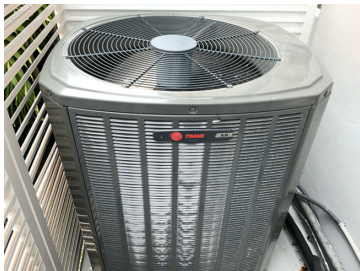
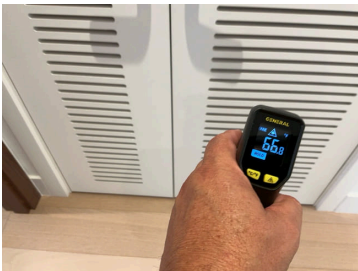
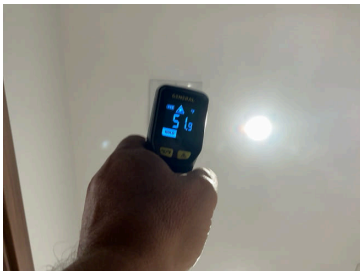
7.1.1 · Air Conditioner  
**Newer Unit**

Positive Attributes: The unit is relatively newer and appears to have been maintained well. Regular maintenance will, of course, be necessary.

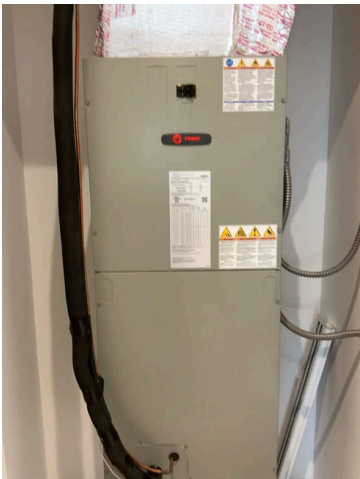
7.2.1 · Air Handler  
**NEWER**

Positive Attributes: The unit is relatively newer. Regular maintenance will, of course, be necessary.

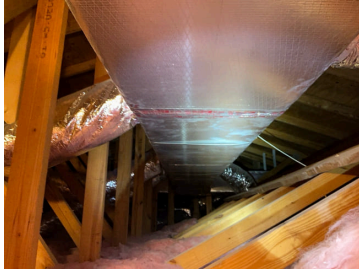
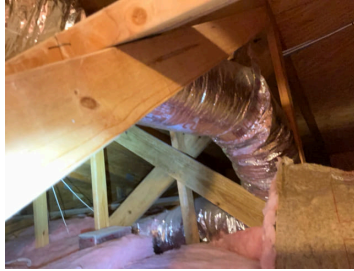
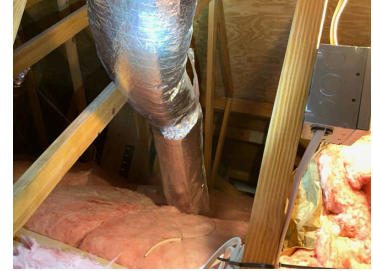
7.4.2 · Ductwork

\*Positive Attributes: The visible ductwork, within the accessible portions of the attic, appear to be in, generally, satisfactory/good condition.

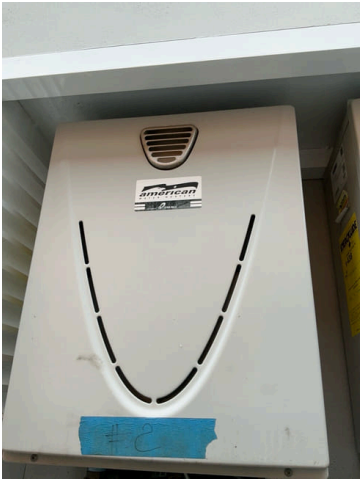
**Hot Water:**

Hot water was obtained at all of the fixtures throughout the property.

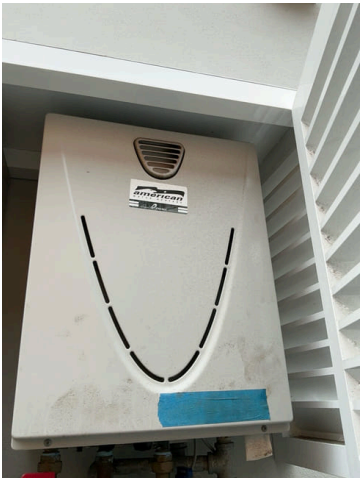
10.1.2 · Water Heater

**Hot Water:**

Hot water was obtained at all of the fixtures throughout the property.

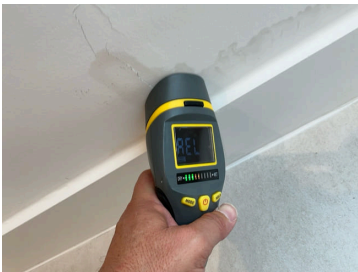
Florida Room

STAINS/MOIST

Investigate Further, Possible Repair: Water stains were observed. <> The stains tested moist with a moisture meter today. Anytime water is present and in contact with cellulose material, the opportunity for the existence of mold is possible. Beware of the possibility of "hidden" mold (it is not visible to the naked eye). Mold testing should be considered as part of due diligence. \*Approximate Investigation Costs: +/- \$250 to +/- \$350 for further investigation ONLY, depending on conclusions and approach. In this case, specific estimates need to be obtained from licensed contractors before the end of your inspection period.

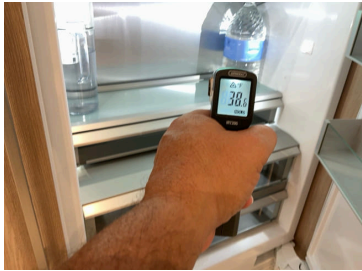
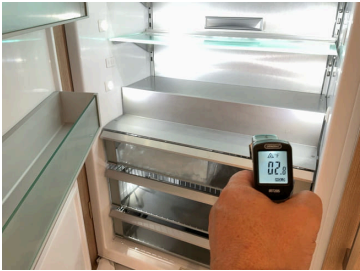
#### 12.2.1 · Refrigerator

**Positive Attributes**

The refrigerator/freezer operated as intended and "normal" temperatures were recorded today (ice makers, water dispensers and other features are outside the scope of this inspection).

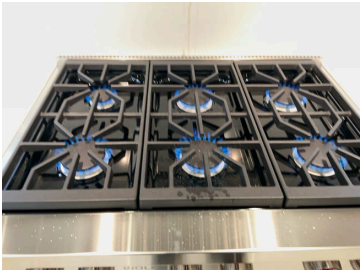
#### 12.3.1 · Range

**Positive Attributes**

All the range heating elements operated when tested.

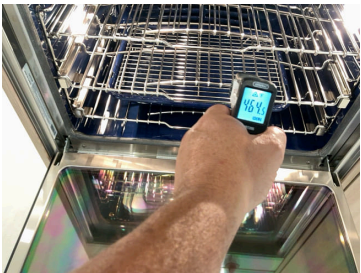
#### 12.4.1 · Oven

**Positive Attributes**

Oven(s) operated when tested.

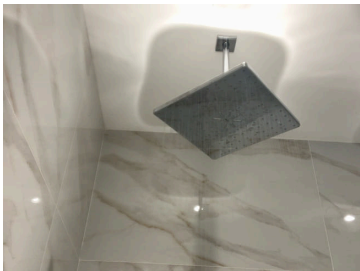
### 14.2.1 · Showers

**Positive Attributes**

The shower(s) operated as intended.

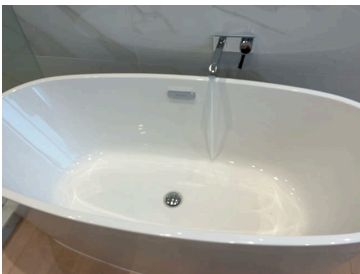
### 14.3.1 · Bath Tubs

**Positive Attributes**

The tub(s) operated as intended.

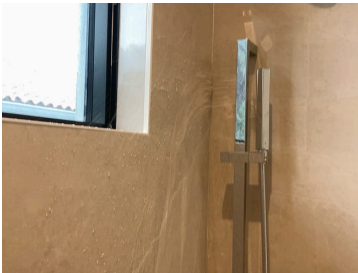
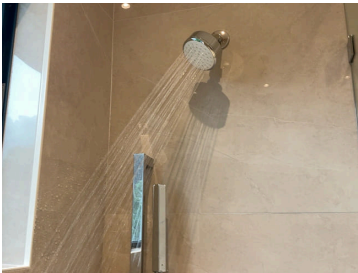
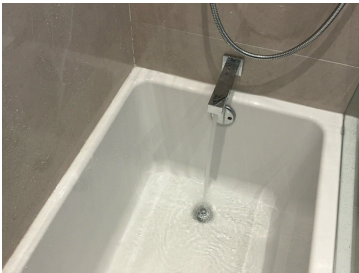
### 15.3.1 · Bath Tubs

**Positive Attributes**

The tub(s) operated as intended.

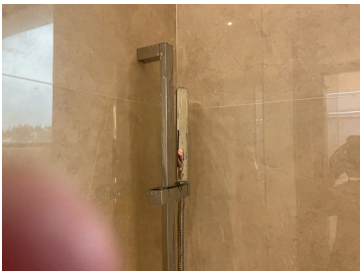
#### 16.2.1 · Showers

**Positive Attributes**

The shower(s) operated as intended.

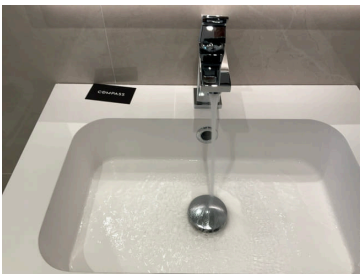
#### 16.4.1 · Sinks

**Positive Attributes**

The sink(s) operated as intended.

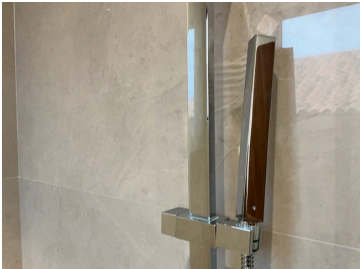
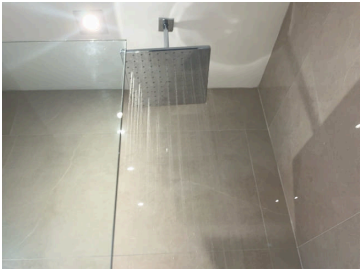
### 17.2.1 · Showers

**Positive Attributes**

The shower(s) operated as intended.

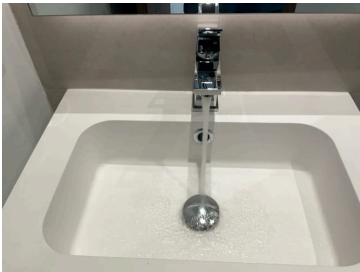
### 17.4.1 · Sinks

**Positive Attributes**

The sink(s) operated as intended.

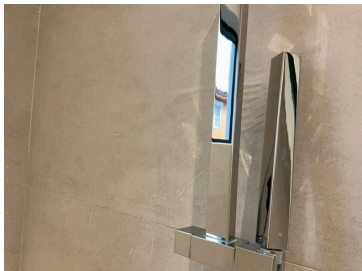
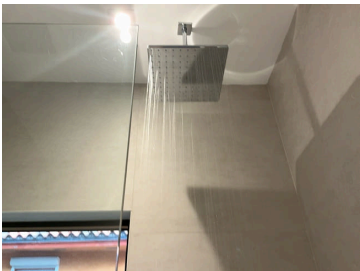
#### 18.2.1 · Showers

**Positive Attributes**

The shower(s) operated as intended.
